REQUEST FOR PROPOSALS (RFP)

WATER AND WASTEWATER FACILITIES OPERATION AND MAINTENANCE SERVICES

The Corporation of the Town of Moosonee

AECOM was retained by the Town of Moosonee for Professional Services related to the inspection of Butler Creek, Ferguson Road, Quarry Road and Atim Road Bridges in accordance with the Ontario Structure Inspection Manual. This report summarizes the findings of the 2022 inspections including updated municipal structure inspection forms with recommendations for required bridge maintenance, rehabilitation and/or replacements.

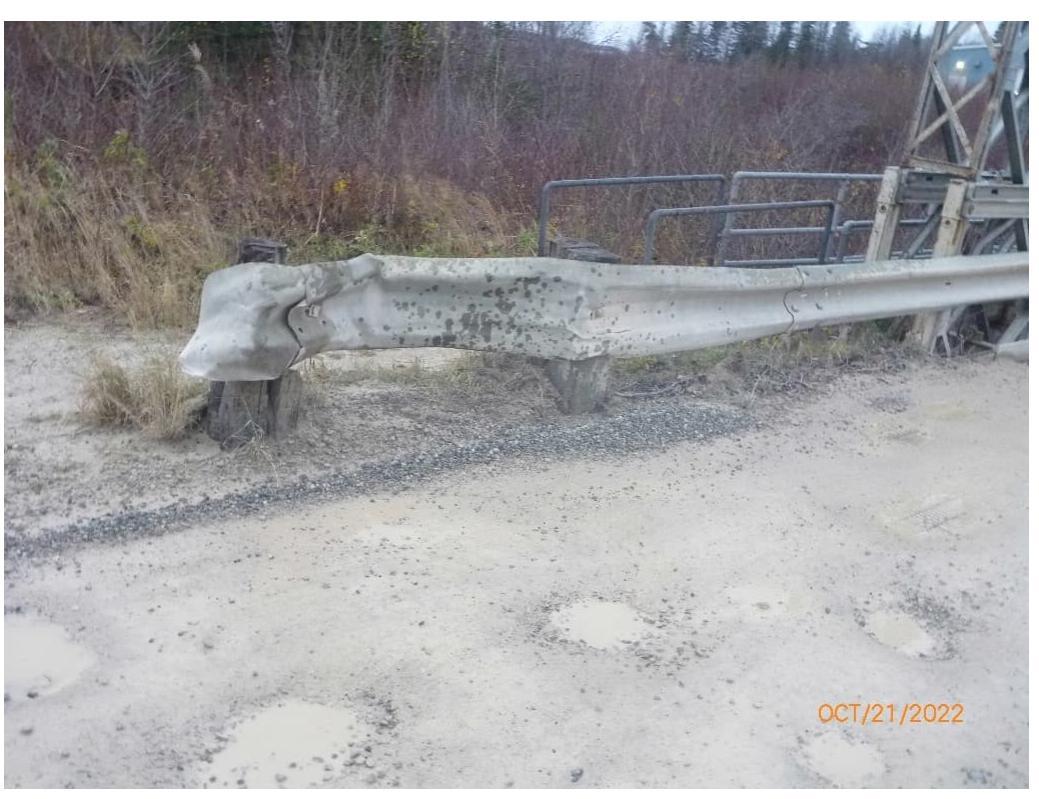
Impact Damage to Guiderail in Northeast Quadrant

- Replace the Northeast and Southeast approach steel flex beam guide rails.
- Remove dirt and gravel on the abutments and bearings.
- Replace missing bottom panel on handrail.
- Re-torque all transom clamps.
- Tighten swaybraces and re-torque raker bolts as per manufacturer's instruction.

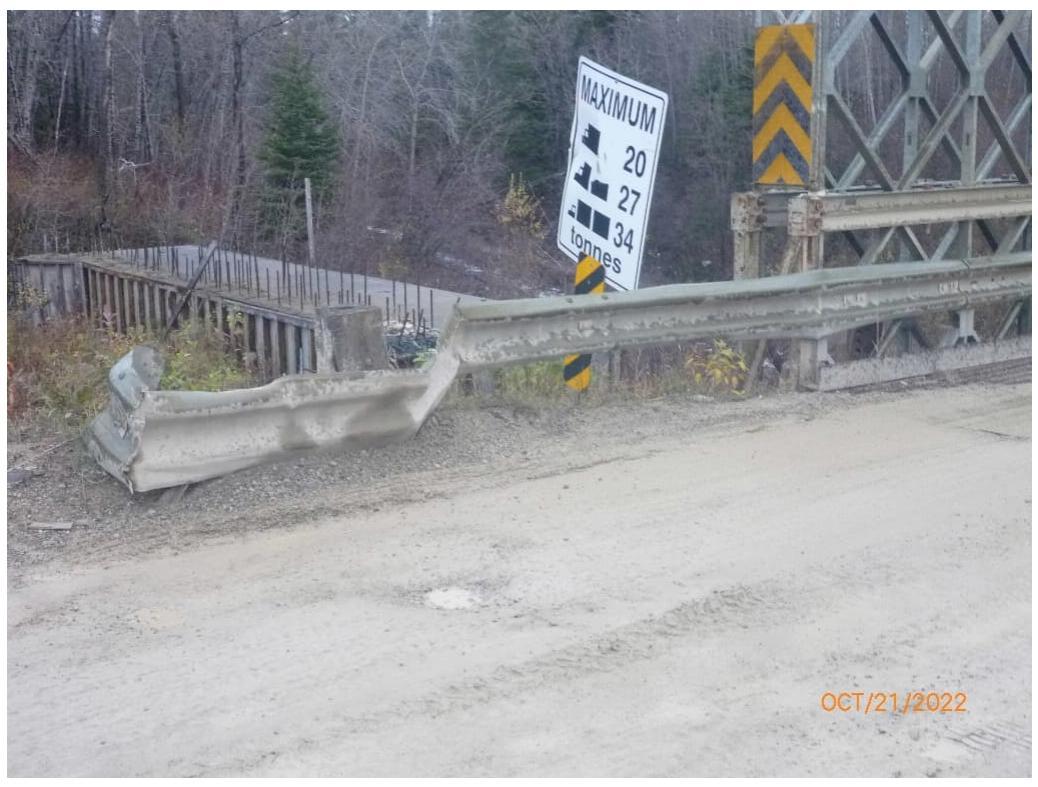
Impact Damage to Guiderail in Southwest Quadrant

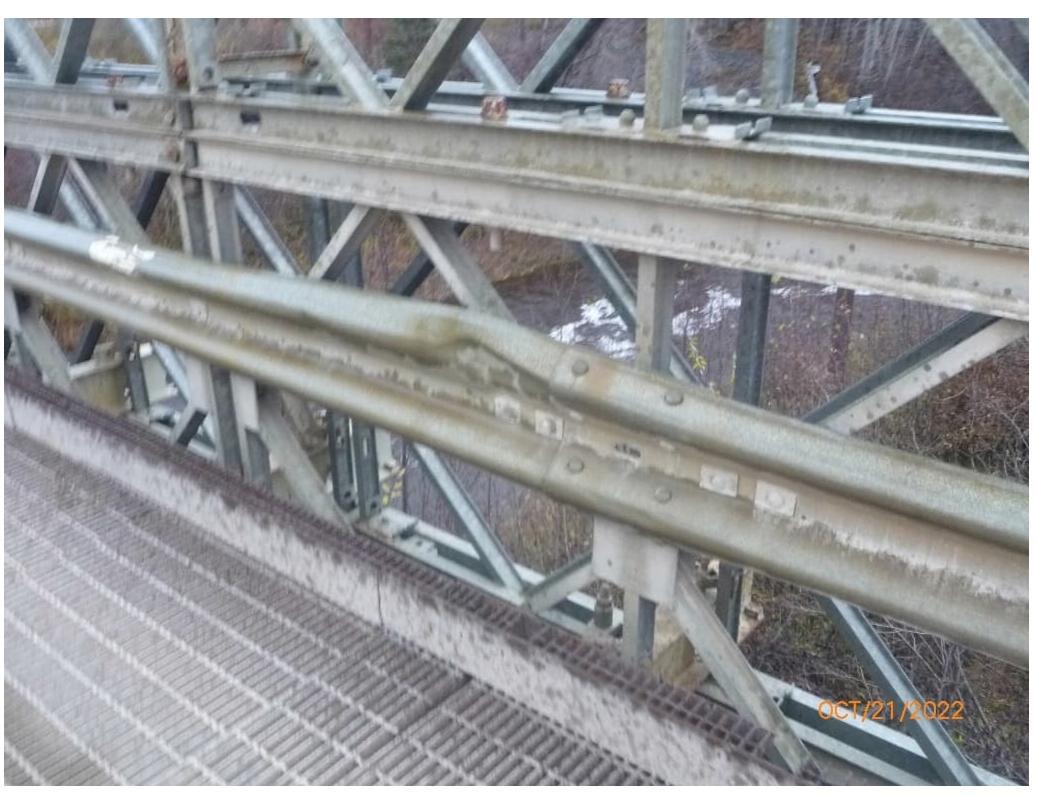
Impact Damage to Centre of West Guiderail

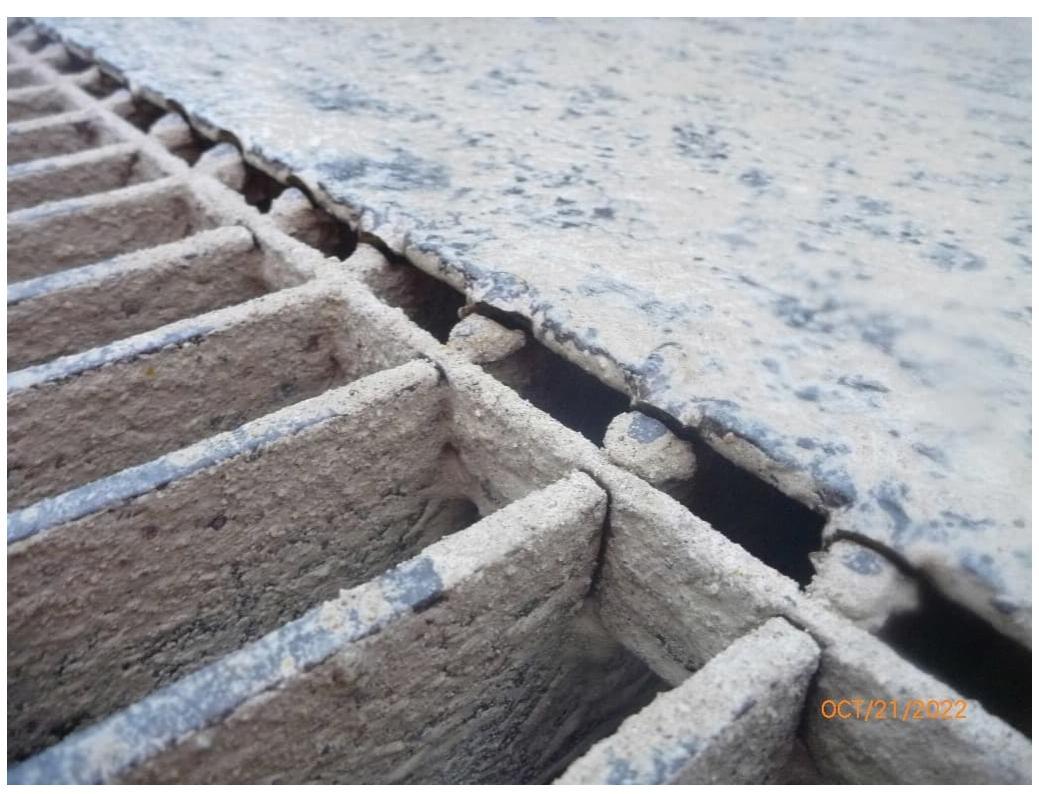
Welds Cracked at decking steel plates

- Repair longitudinal welds on the deck plates.
- Replace or modify the walkway railing to meet bridge code requirement.

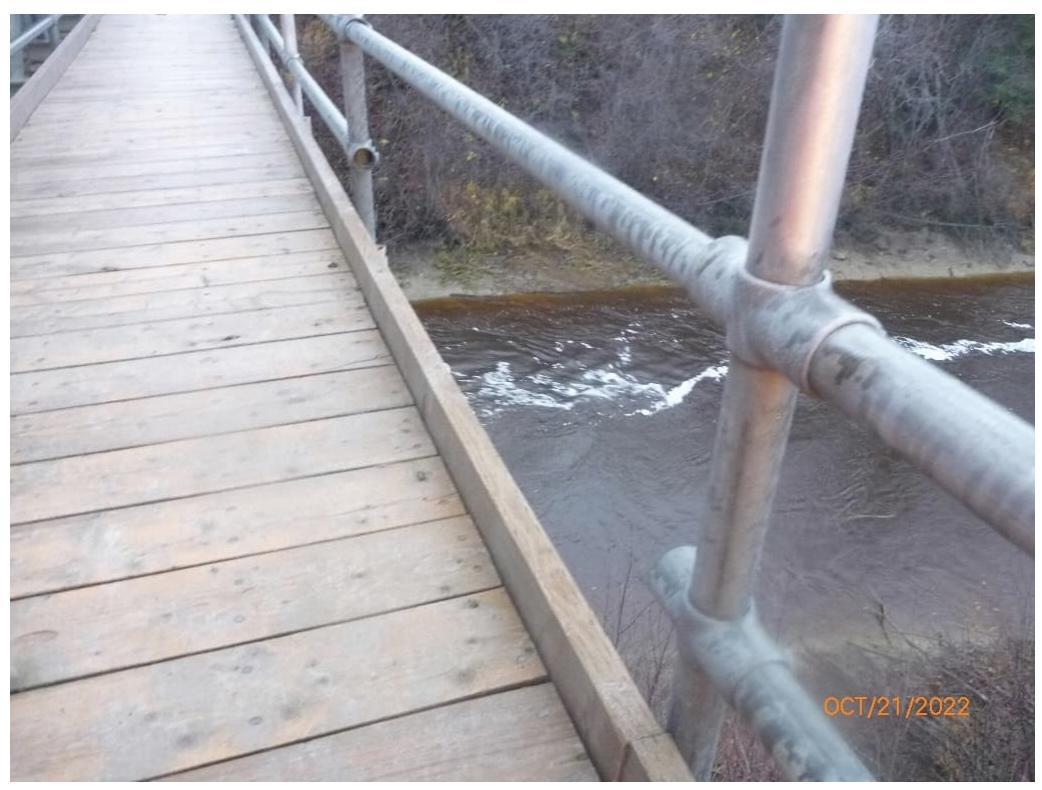
Missing Bottom Panel on Exterior Handrail

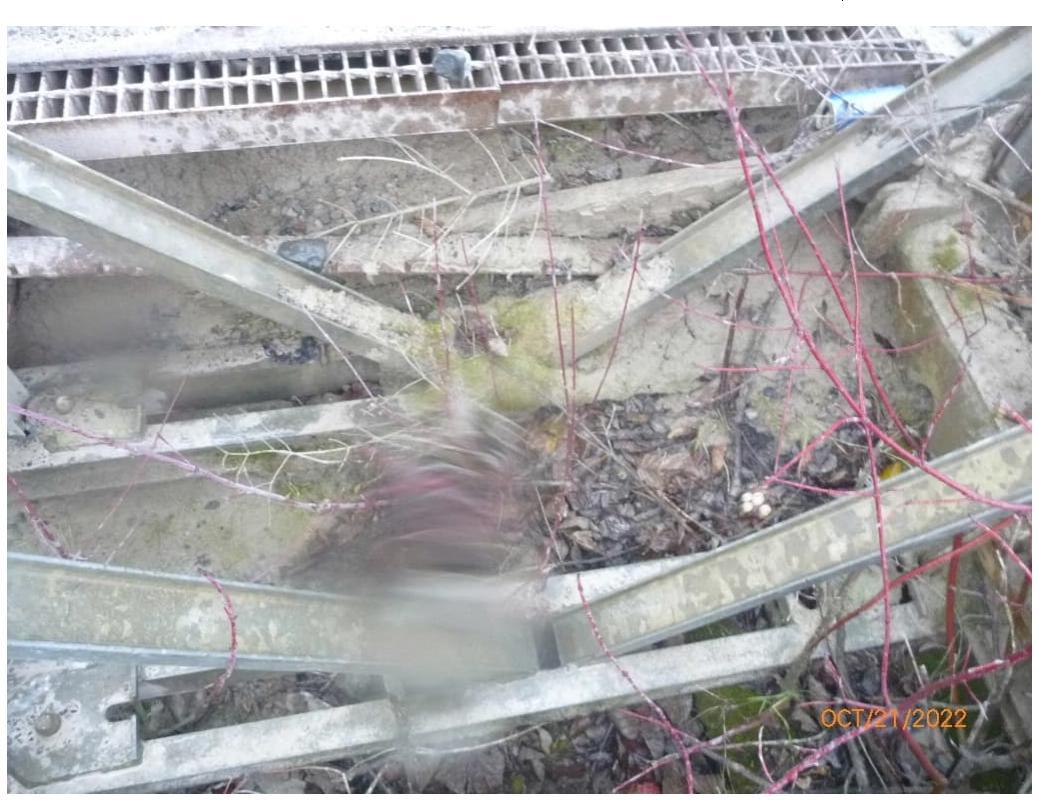
Abutment Bearings Buried in Sand

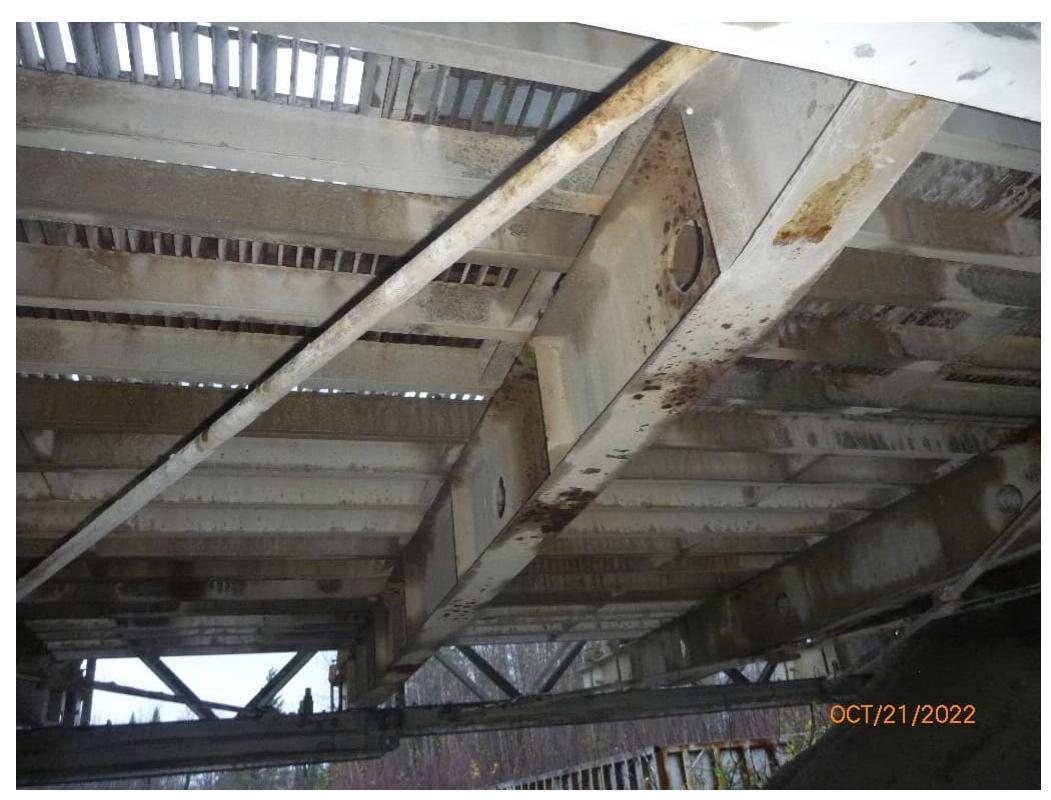
Typical Light Corrosion on Floor Beam

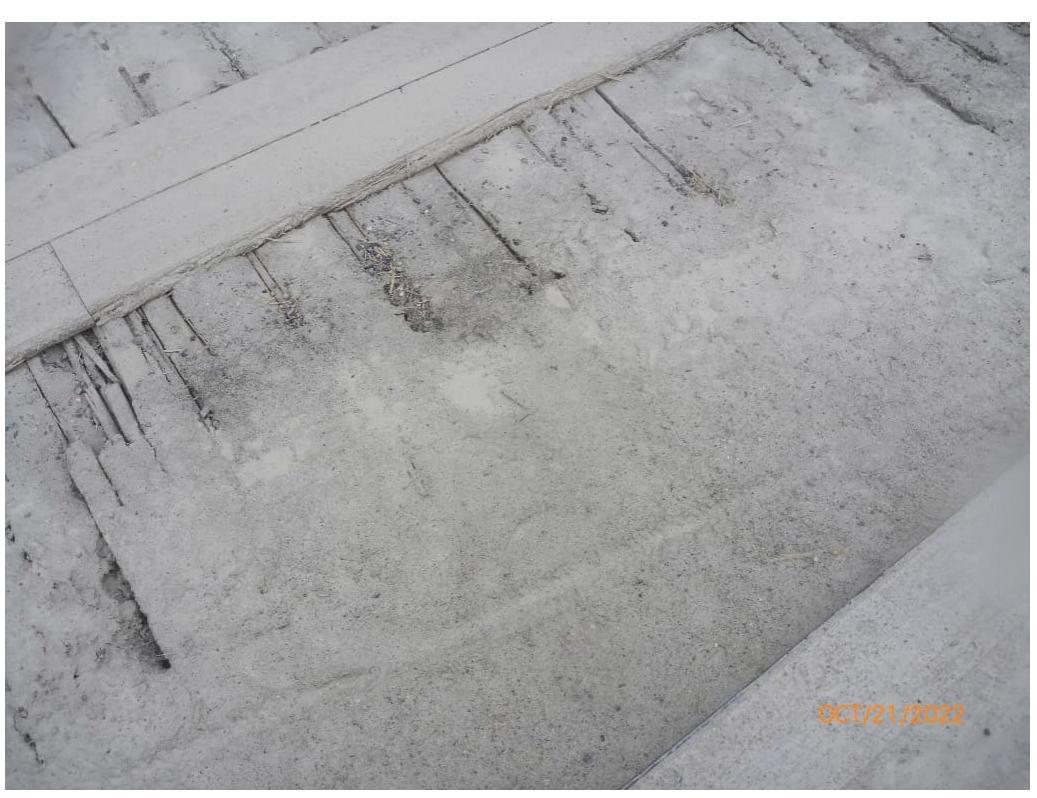
Typical Sand and Gravel Covering Deck

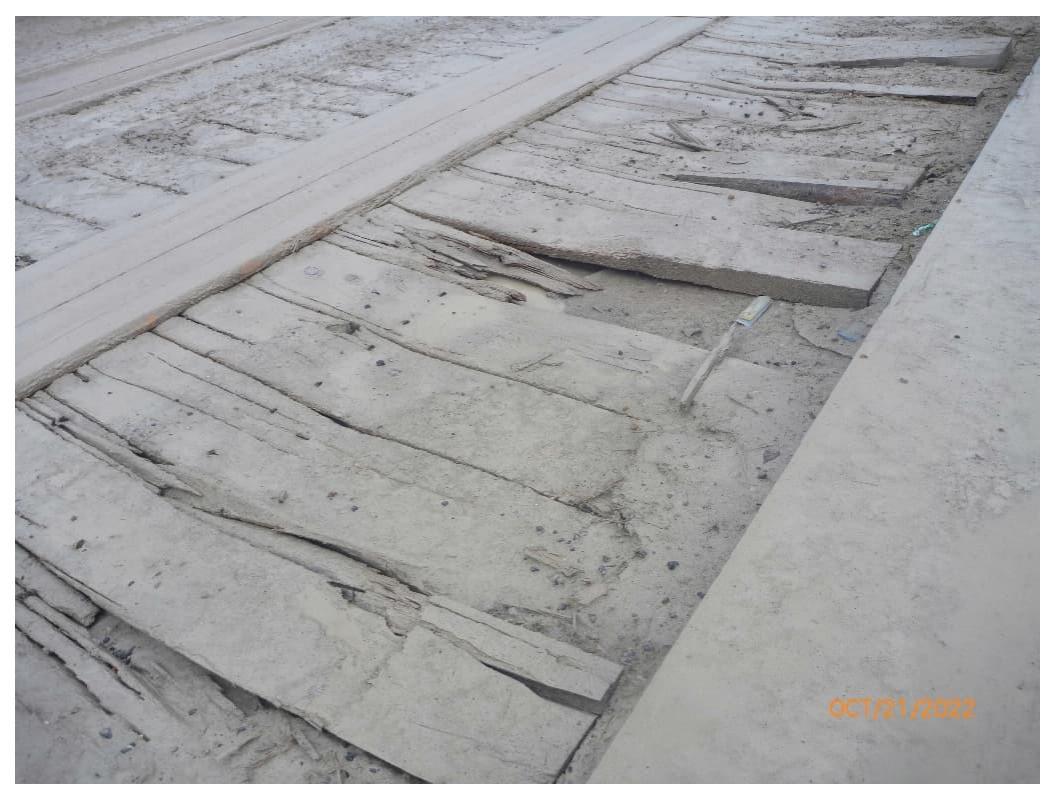
Rotten and Broken Transverse Deck Boards along East Sidewalk

- Replace missing nut on North abutment diaphragm uplift tie-down.
- Remove and replace timber deck wearing surface.
- Replacement of laminated transverse timber deck soffit should be considered at the same time.

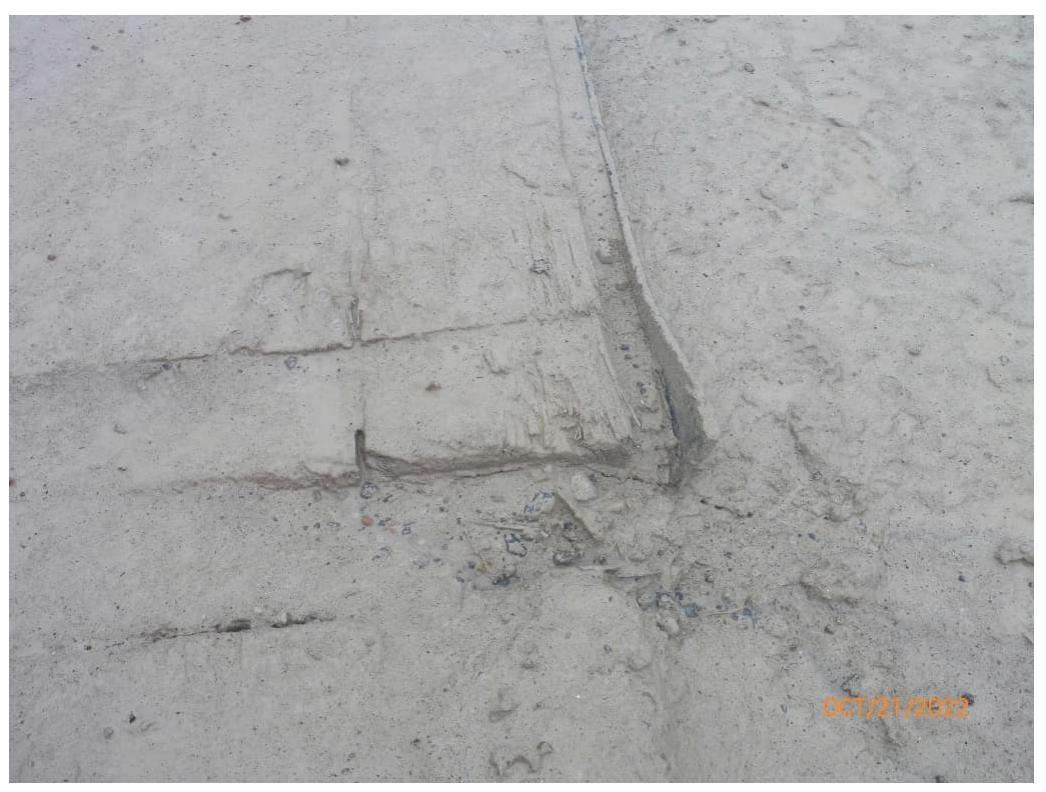
Impact Damage to Edge Plate and Localised Abrasion/Wear near North Expansion Joint.

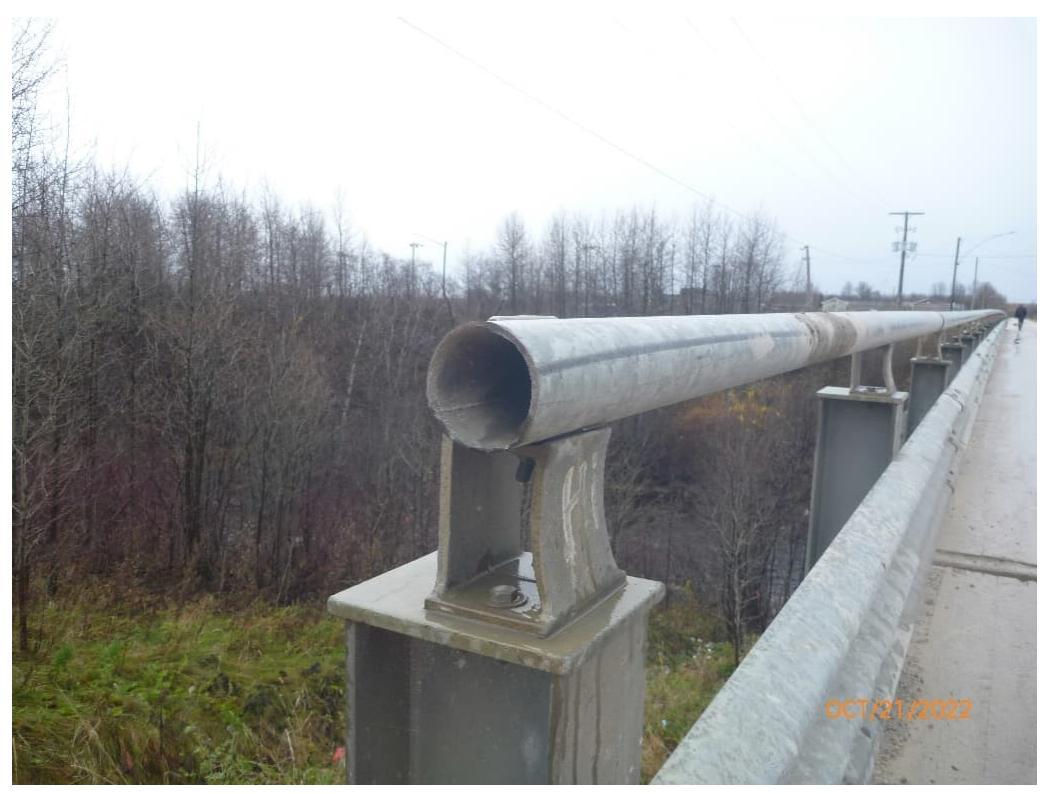
Missing End Cap on Handrail

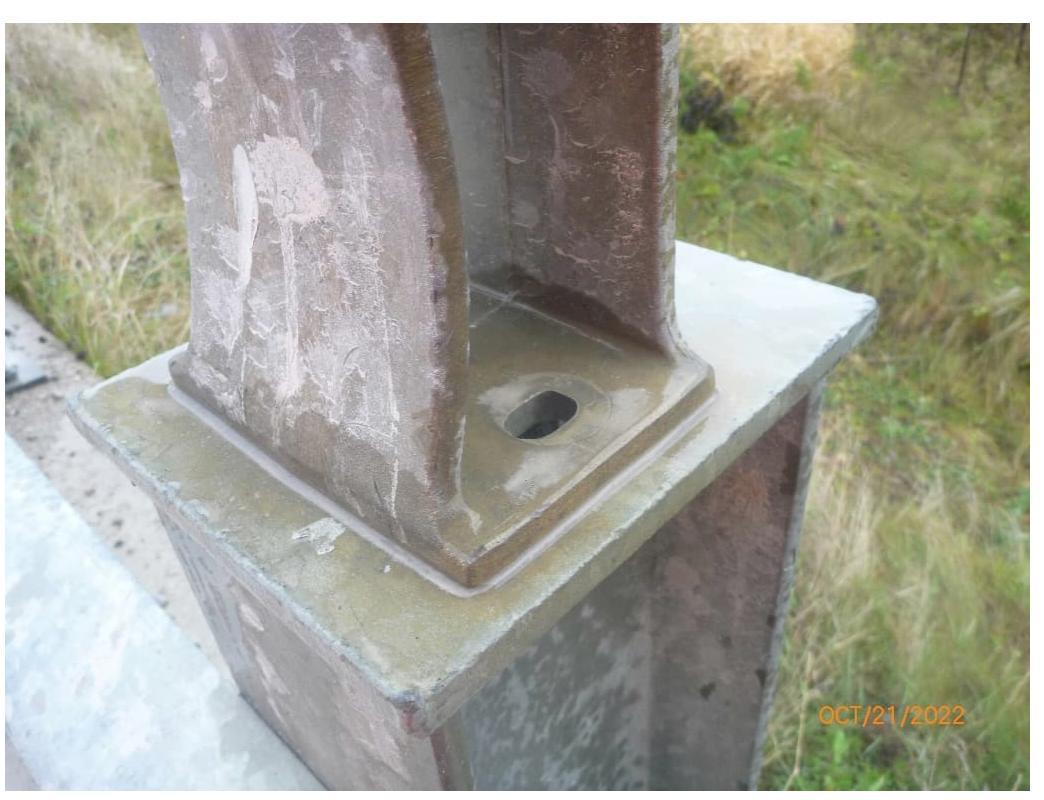
Missing Anchor Bolt on Handrail

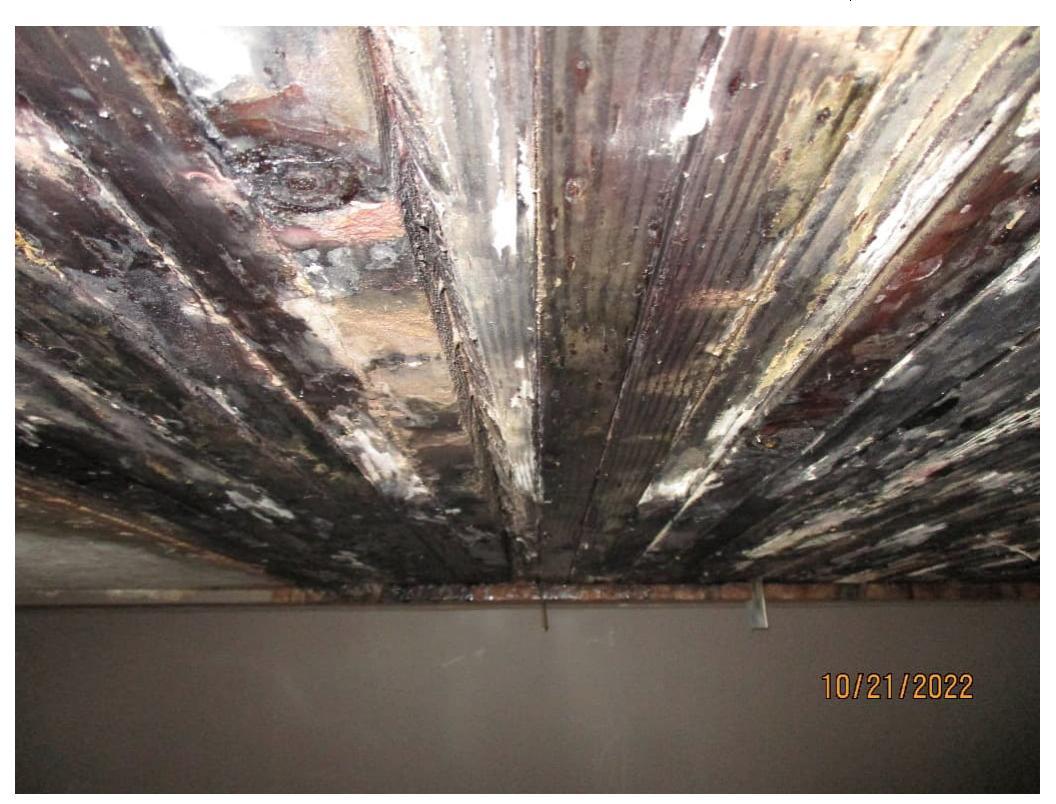
Wet Areas on Soffit

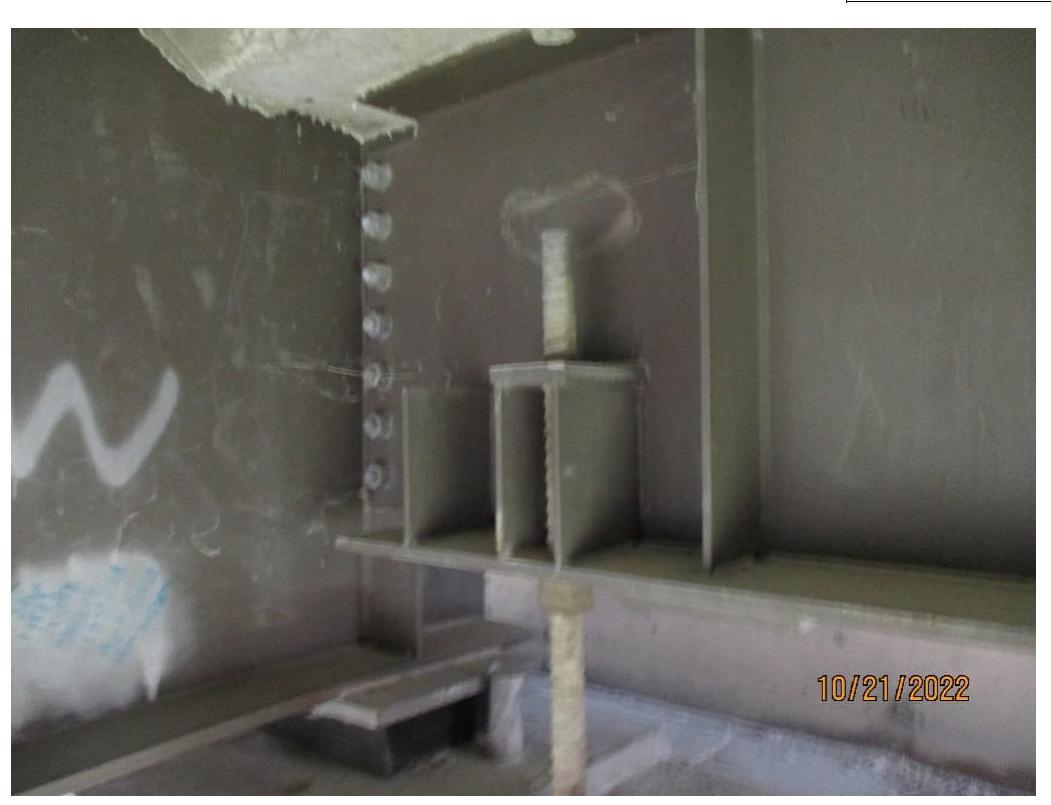
Missing Nut at North Abutment Tie-Down

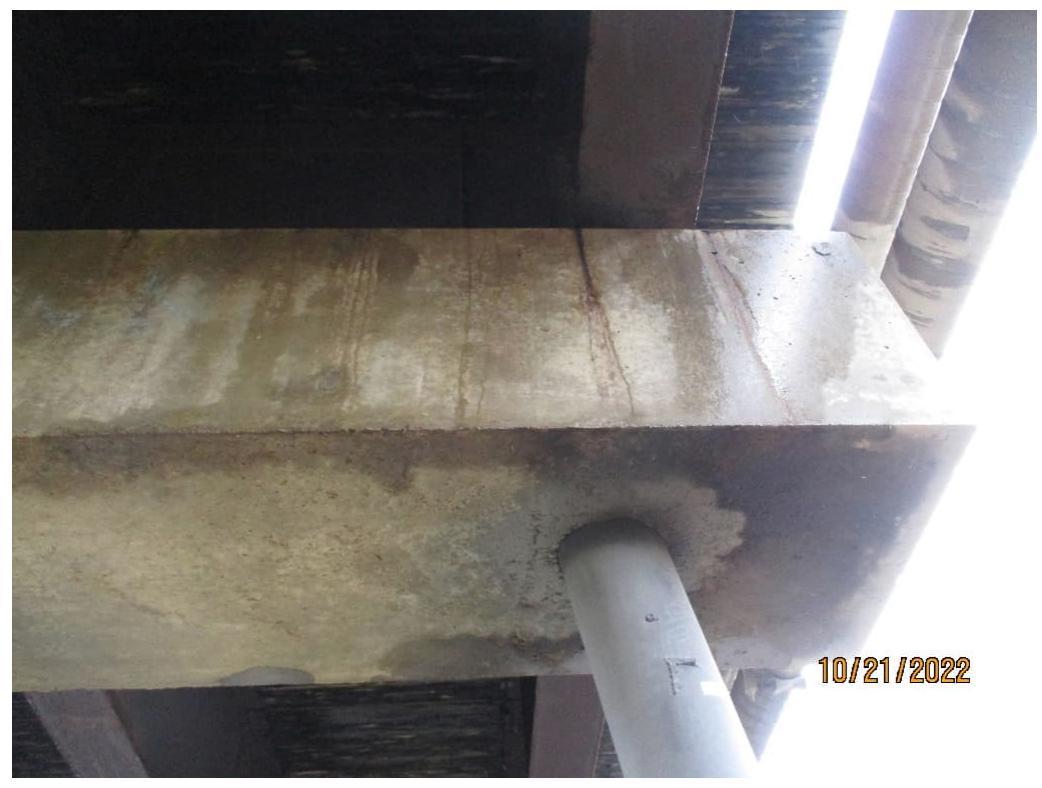
Wet Areas on Pier Cap

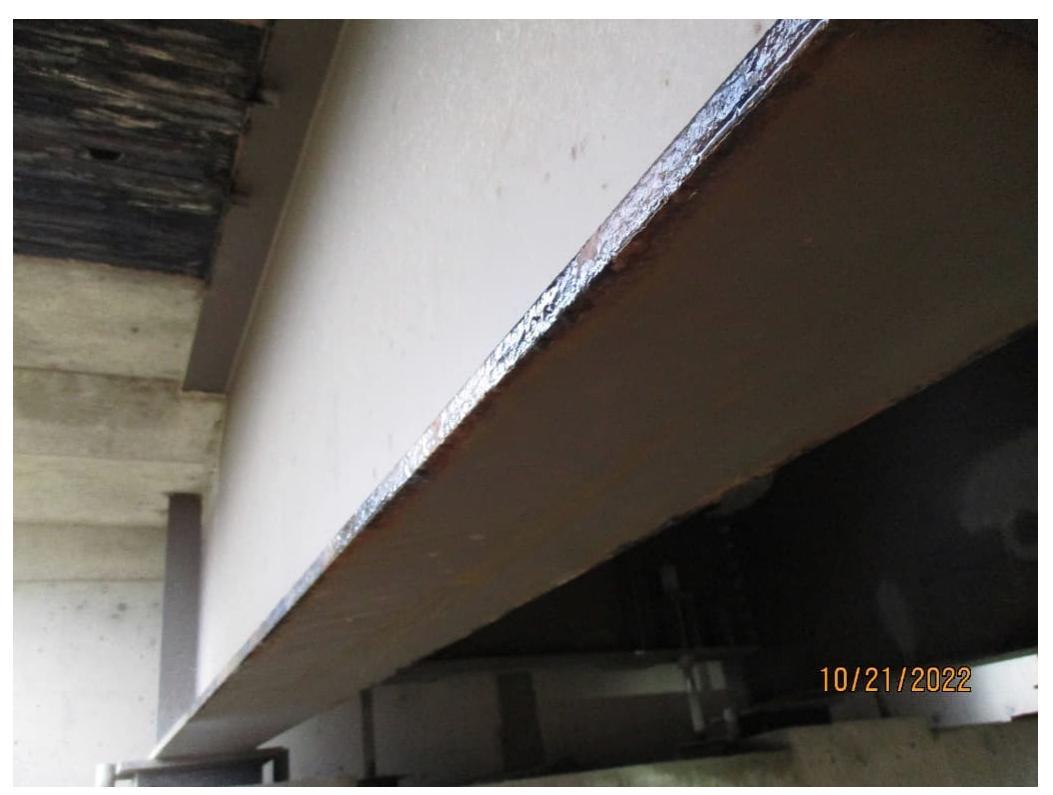
Edge Defect in Coating at Girder End

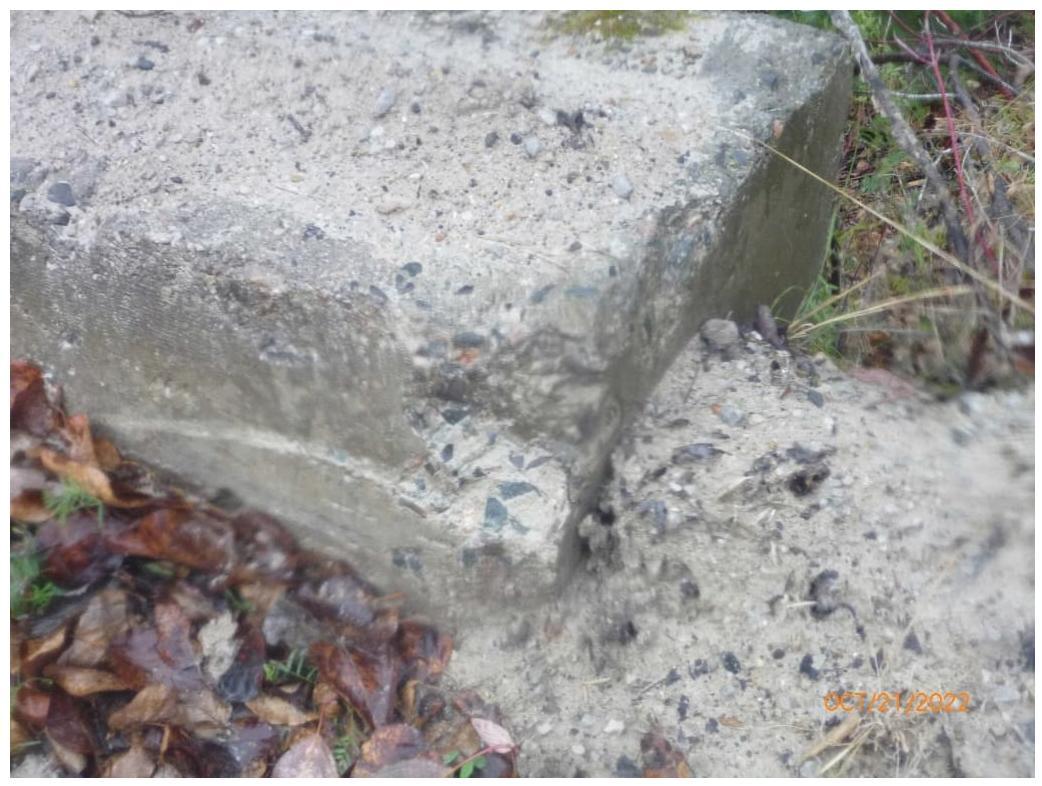
Small Spall on Curb

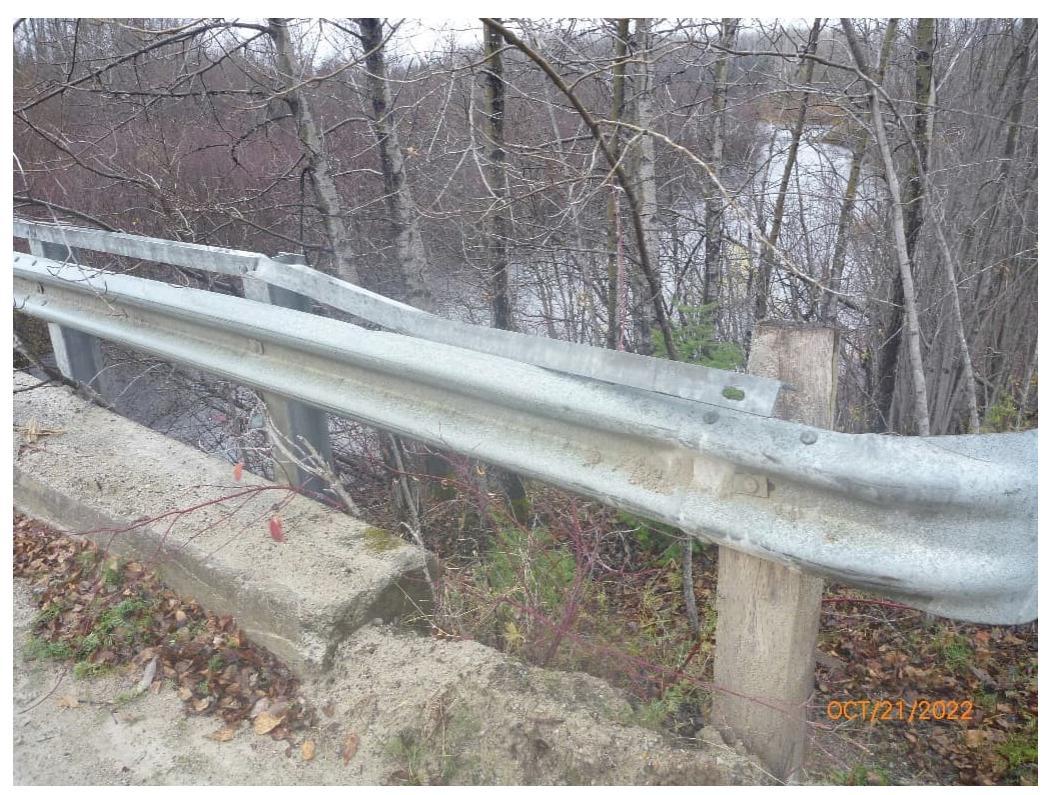
Deformation of Top Rail of Guide Rail

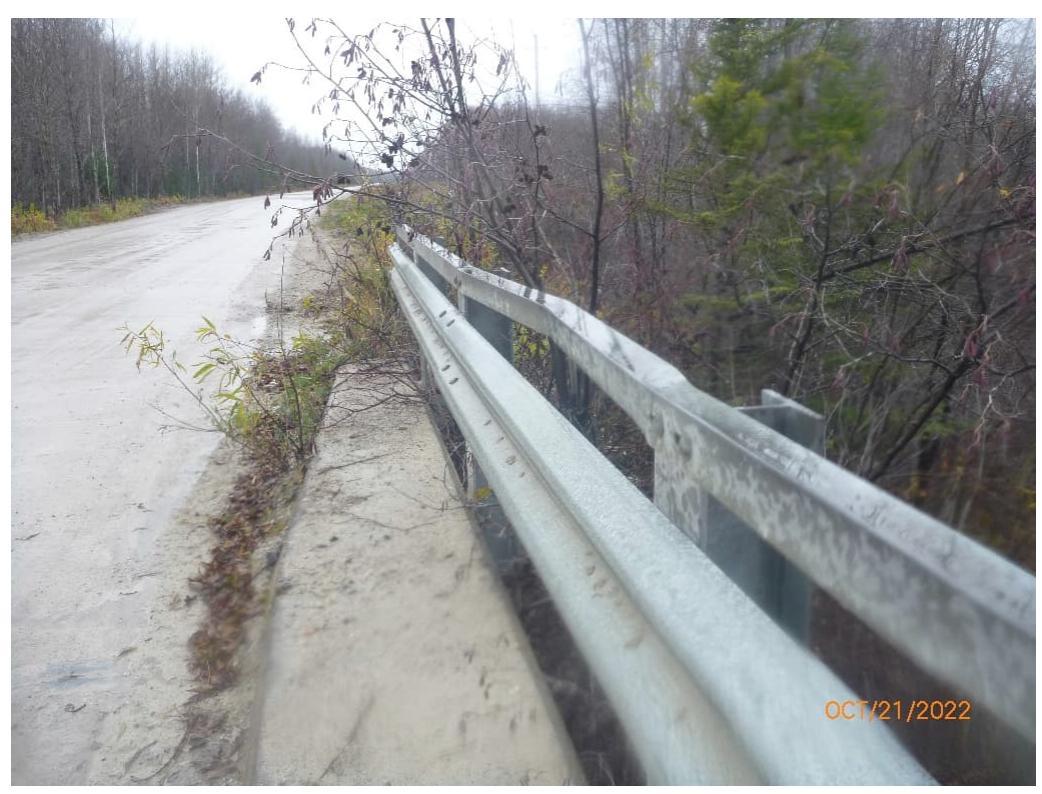
Deformation of Top Rail of Guide Rail

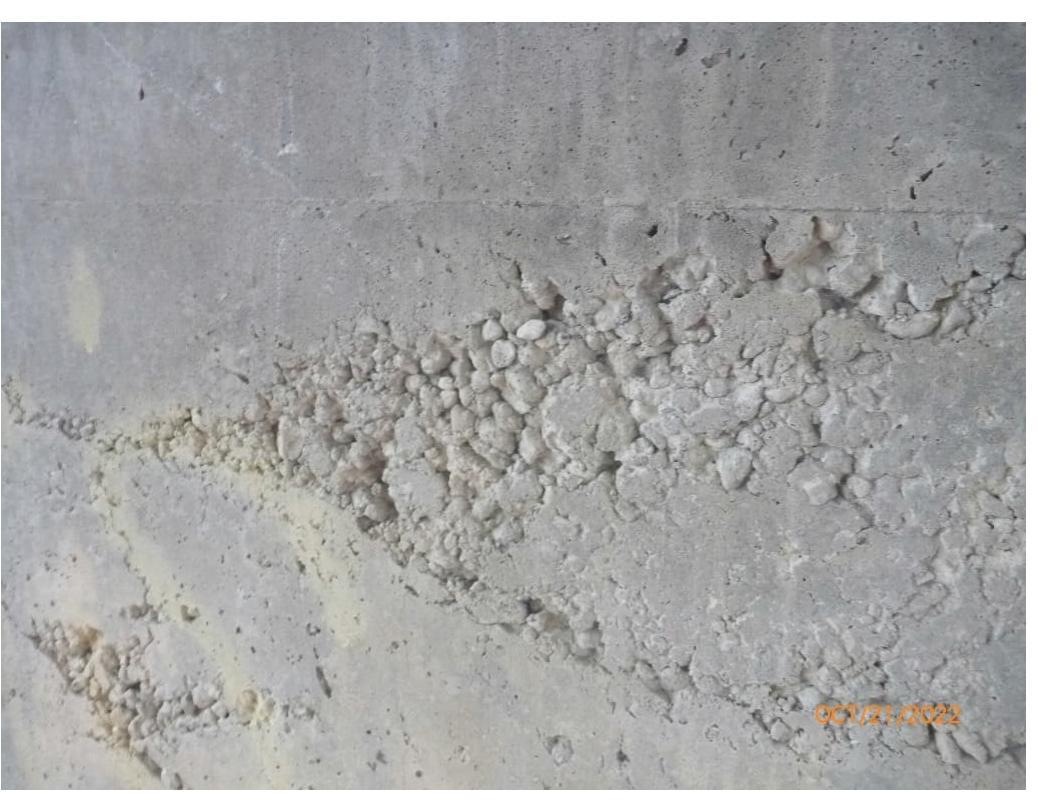
Light Honeycombing on Abutment

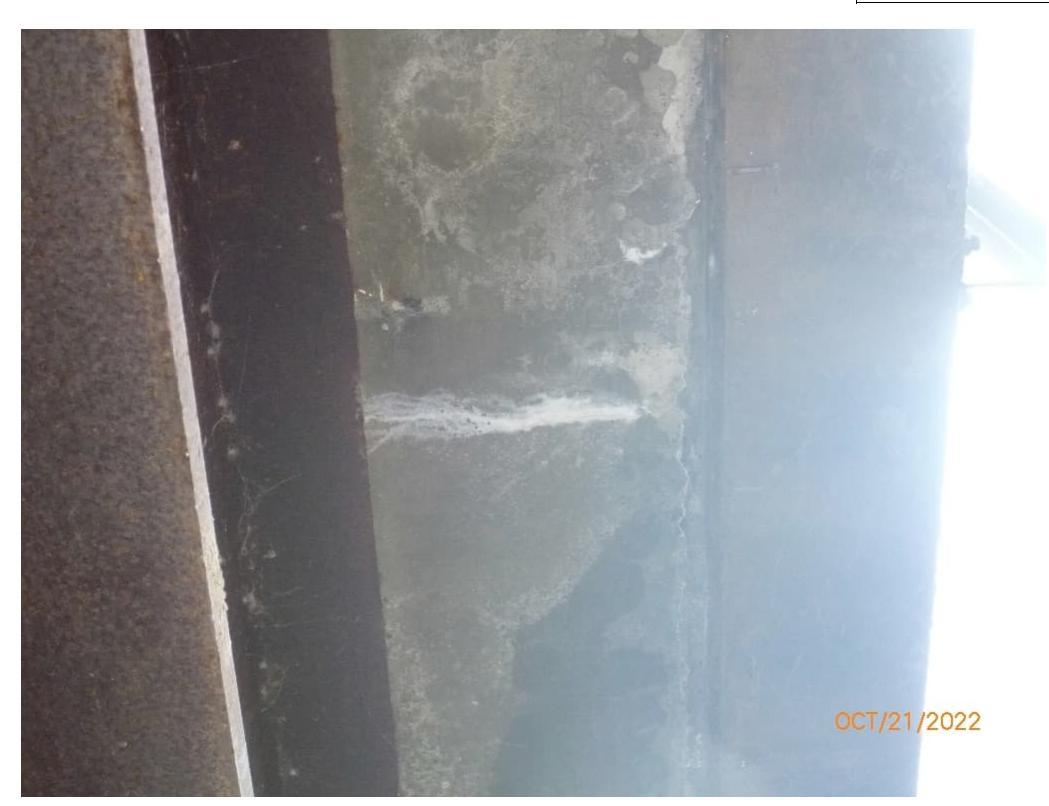
Efflorescence Stained Crack on Exterior Soffit

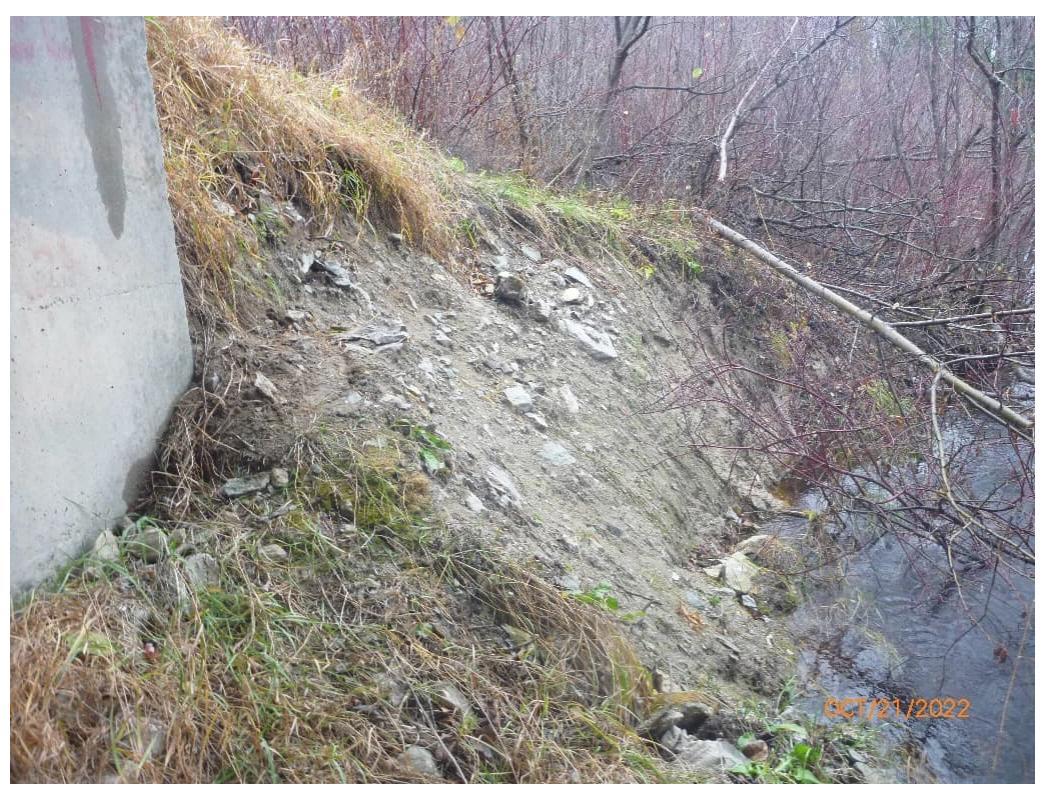
Severe Erosion in Northwest Quadrant

- Repair embankment in Northwest quadrant and place rock protection.
- Repair top rail of guide rail.
- Remove dirt and gravel on the deck.
- Repair potholes on approaches.

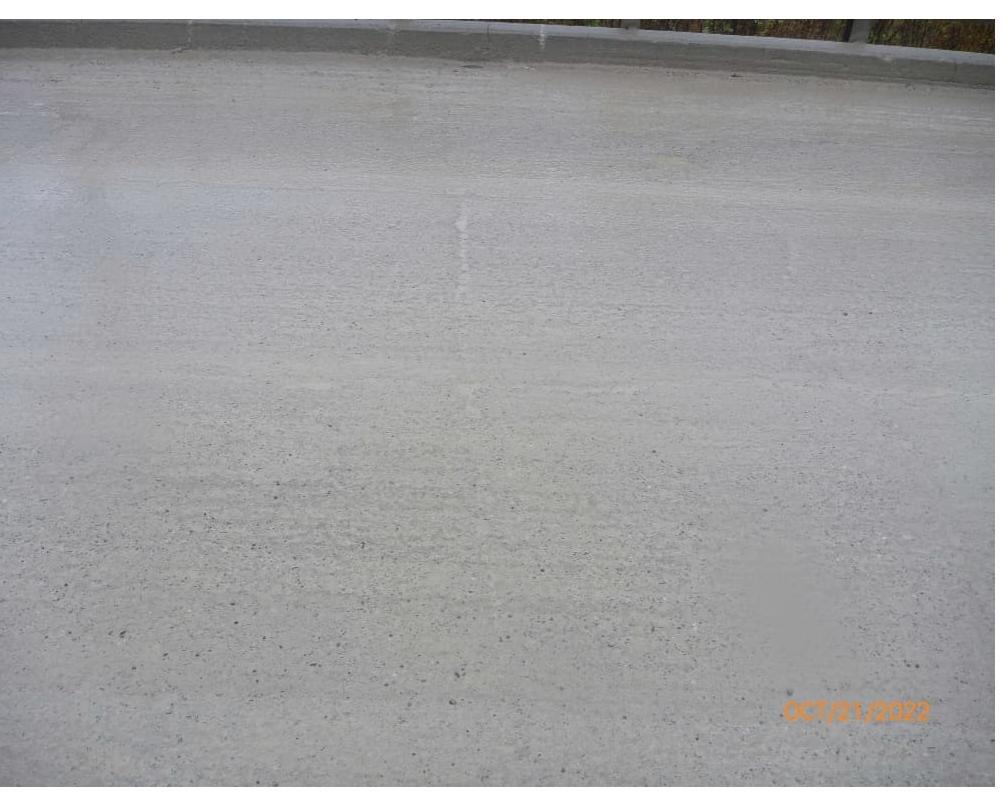
Transverse Crack in Deck Top

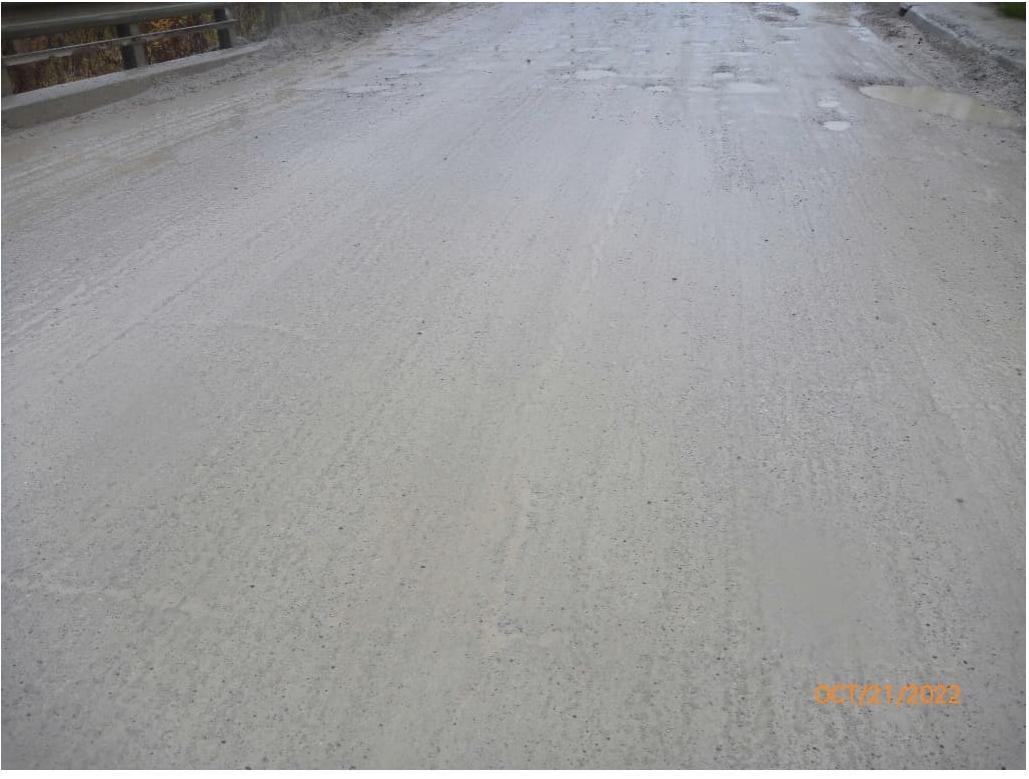
Longitudinal Crack in Deck Top

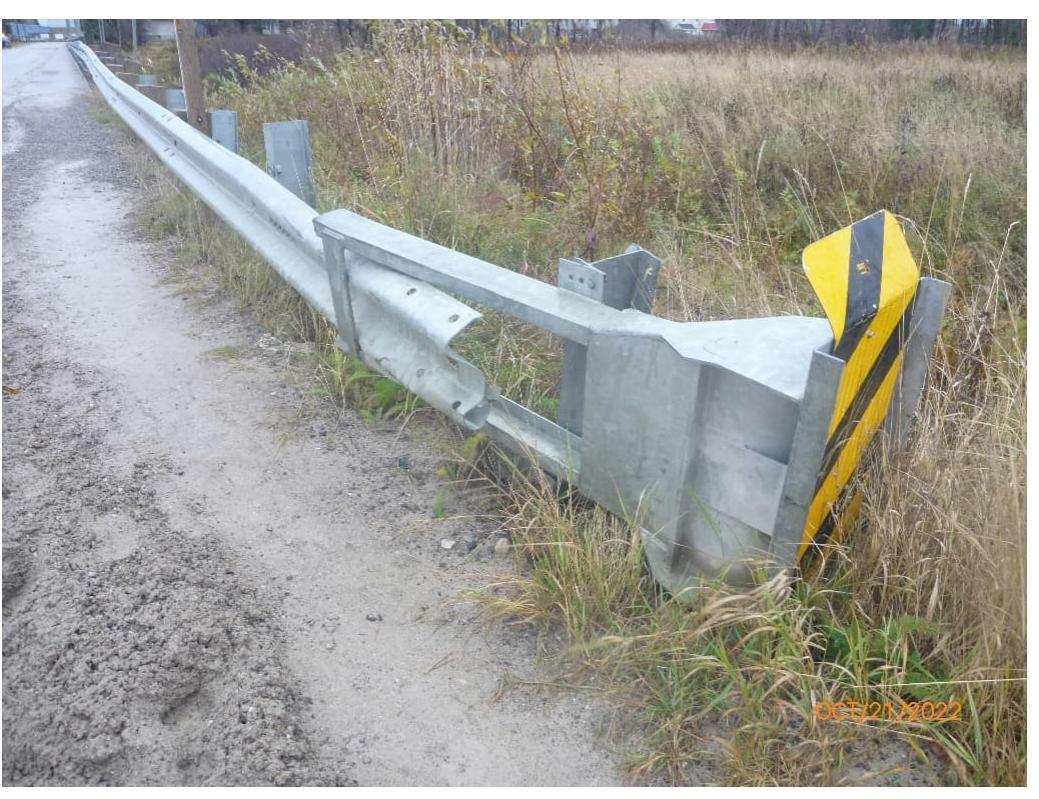
Impact Damage to Attenuator in Southeast Quadrant

- Repair potholes on approaches.
- Remove dirt and gravel on the deck.
- Remove debris in stream.
- Repair attenuator in Southeast quadrant.

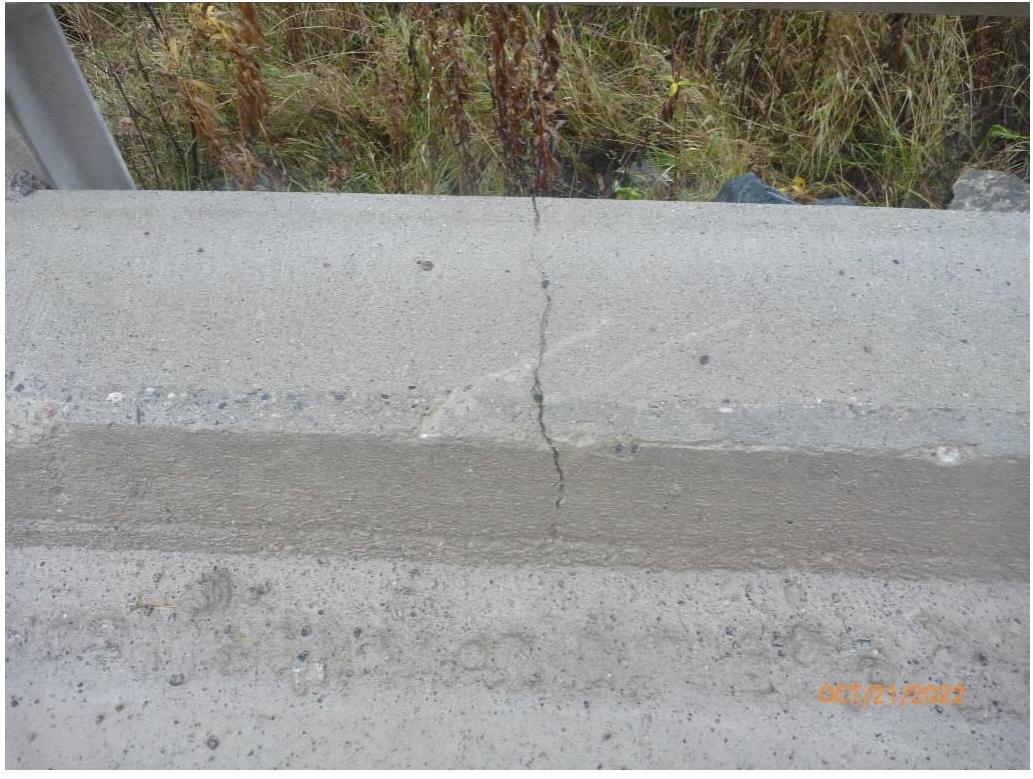
Wide Crack in Curb

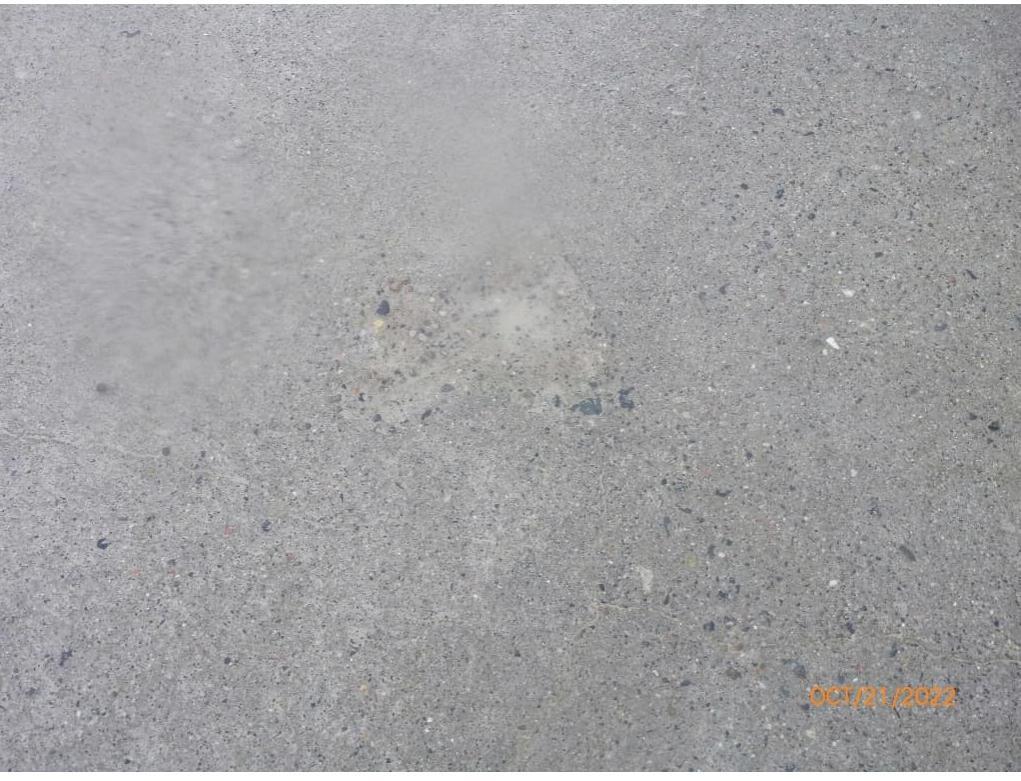
Small spall on Curb
