REQUEST FOR PROPOSALS (RFP)

WATER AND WASTEWATER FACILITIES OPERATION AND MAINTENANCE SERVICES

The Corporation of the Town of Moosonee

AECOM was retained by the Town of Moosonee for Professional Services related to the inspection of Butler Creek, Ferguson Road, Quarry Road and Atim Road Bridges in accordance with the Ontario Structure Inspection Manual. This report summarizes the findings of the 2022 inspections including updated municipal structure inspection forms with recommendations for required bridge maintenance, rehabilitation and/or replacements.

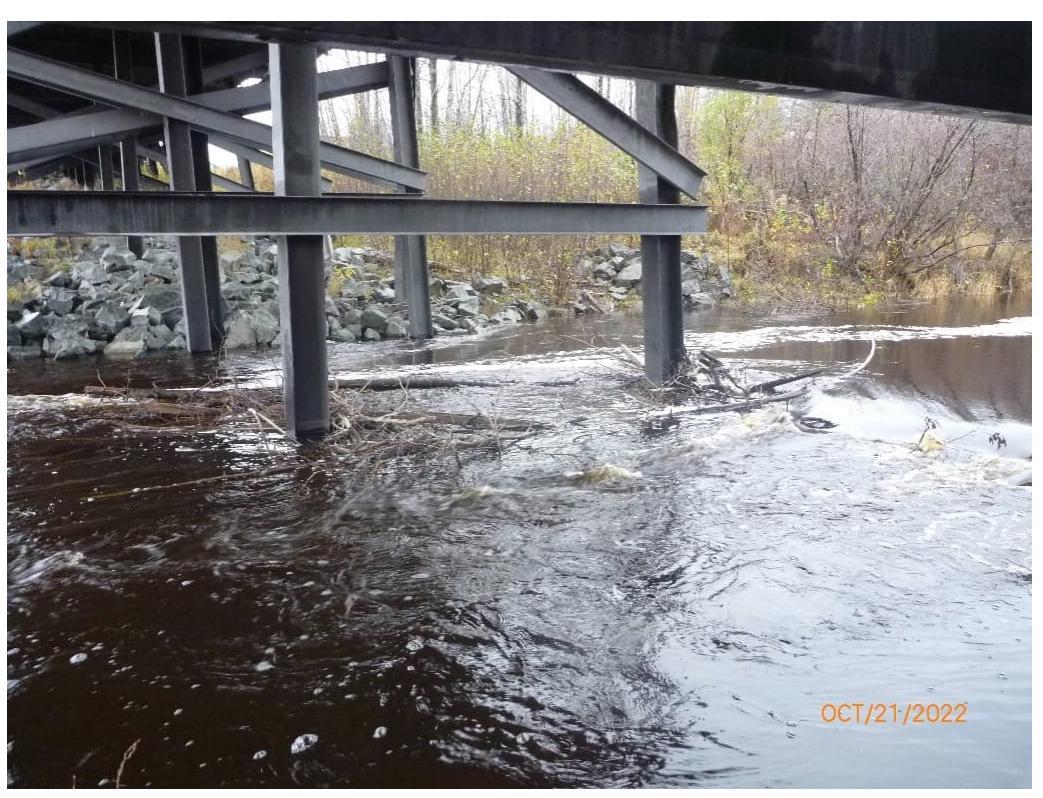
Debris in Stream under Bridge
