REQUEST FOR PROPOSALS (RFP)

WATER AND WASTEWATER FACILITIES OPERATION AND MAINTENANCE SERVICES

The Corporation of the Town of Moosonee

AECOM was retained by the Town of Moosonee for Professional Services related to the inspection of Butler Creek, Ferguson Road, Quarry Road and Atim Road Bridges in accordance with the Ontario Structure Inspection Manual. This report summarizes the findings of the 2022 inspections including updated municipal structure inspection forms with recommendations for required bridge maintenance, rehabilitation and/or replacements.

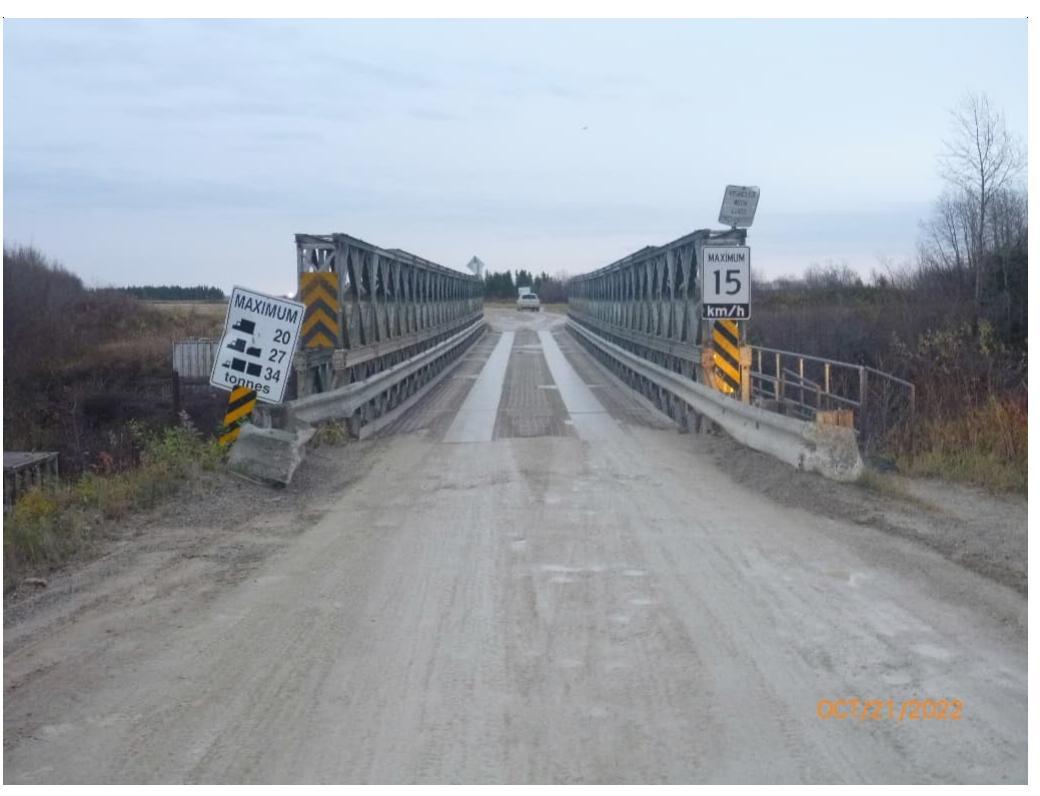
Looking North at Bridge

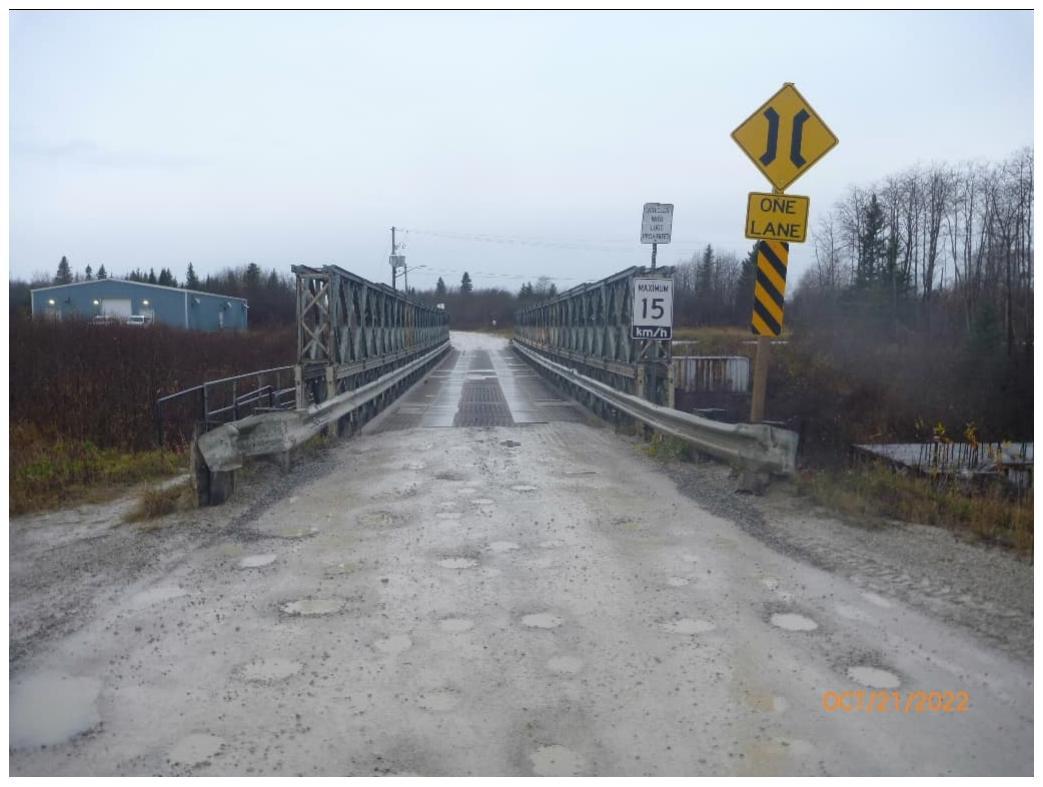
Looking South at Bridge

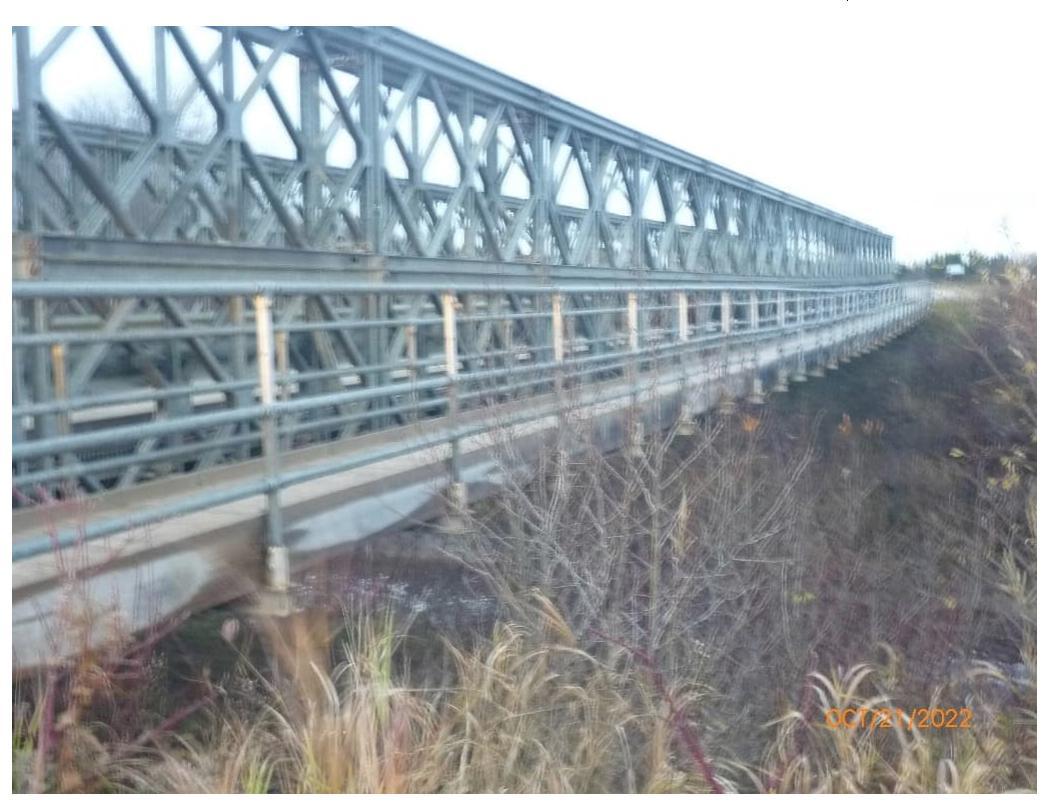
East Elevation

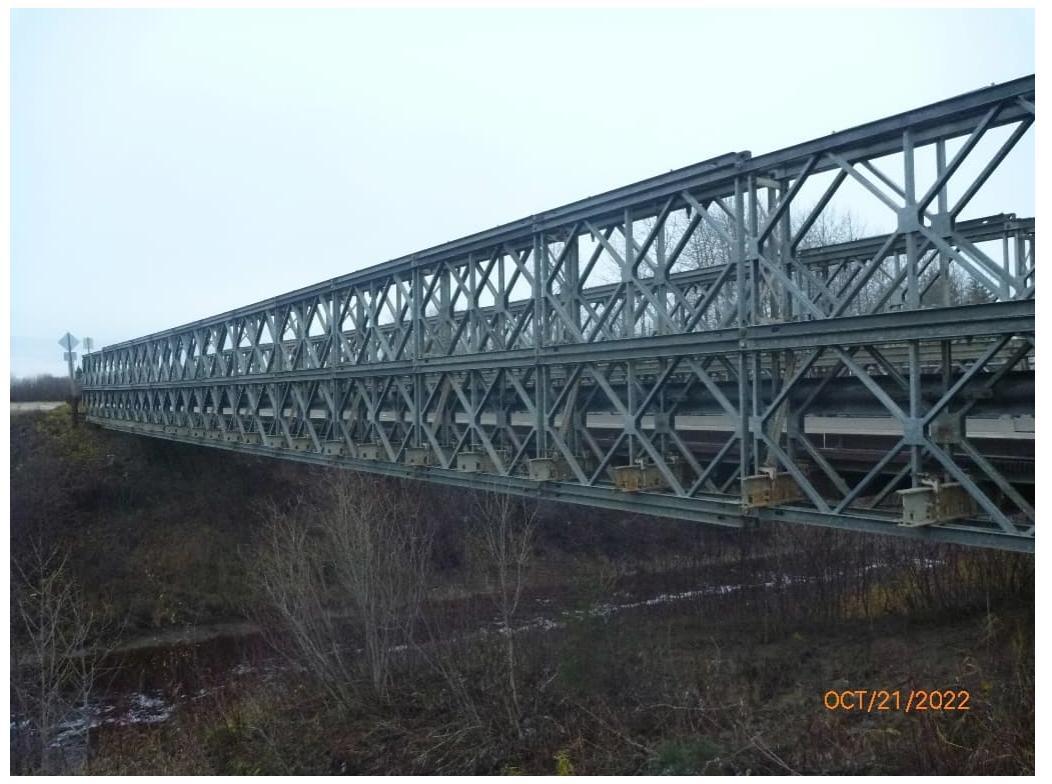
West Elevation

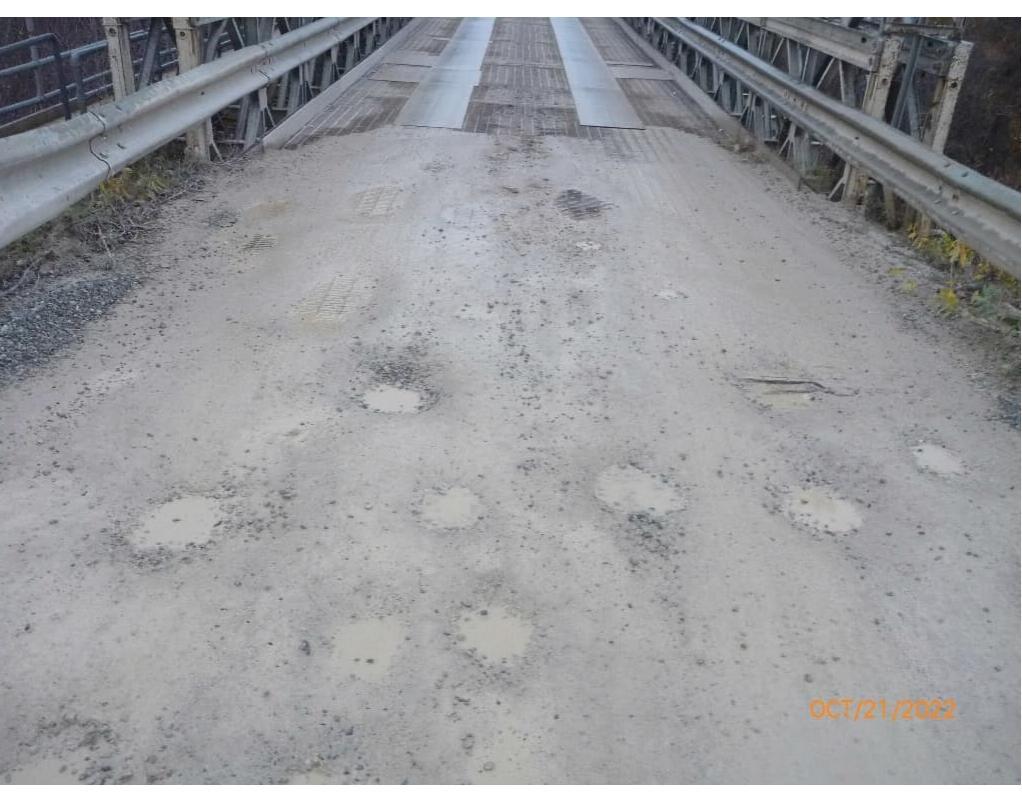
North Approach

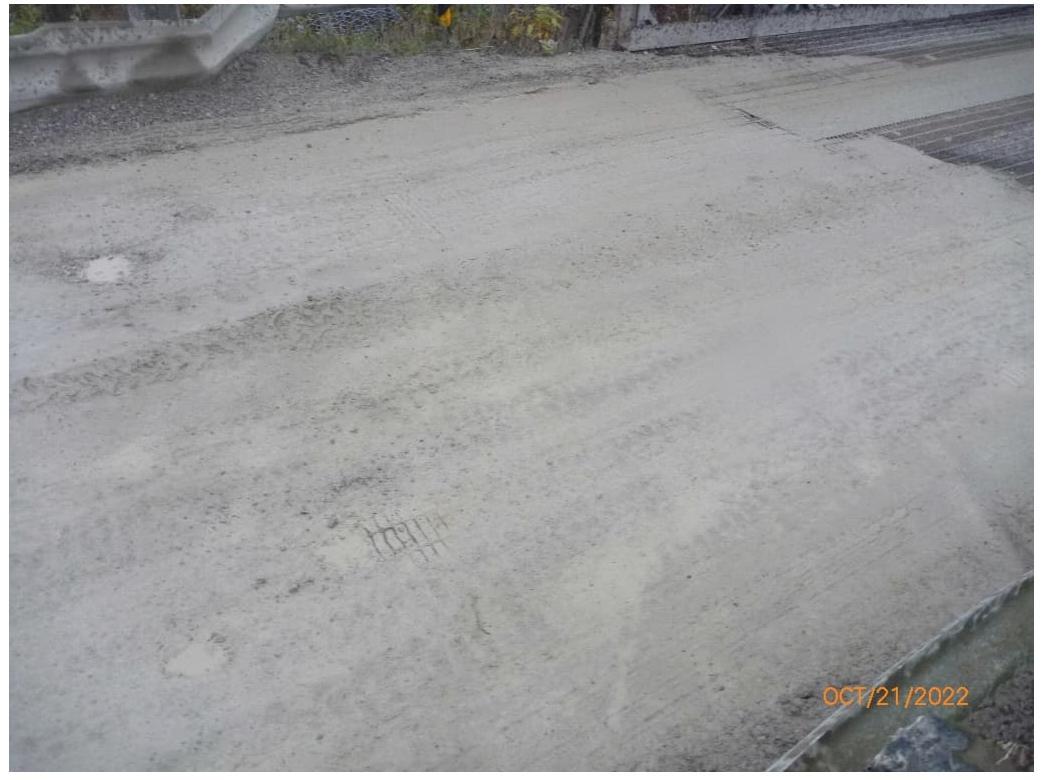
South Approach

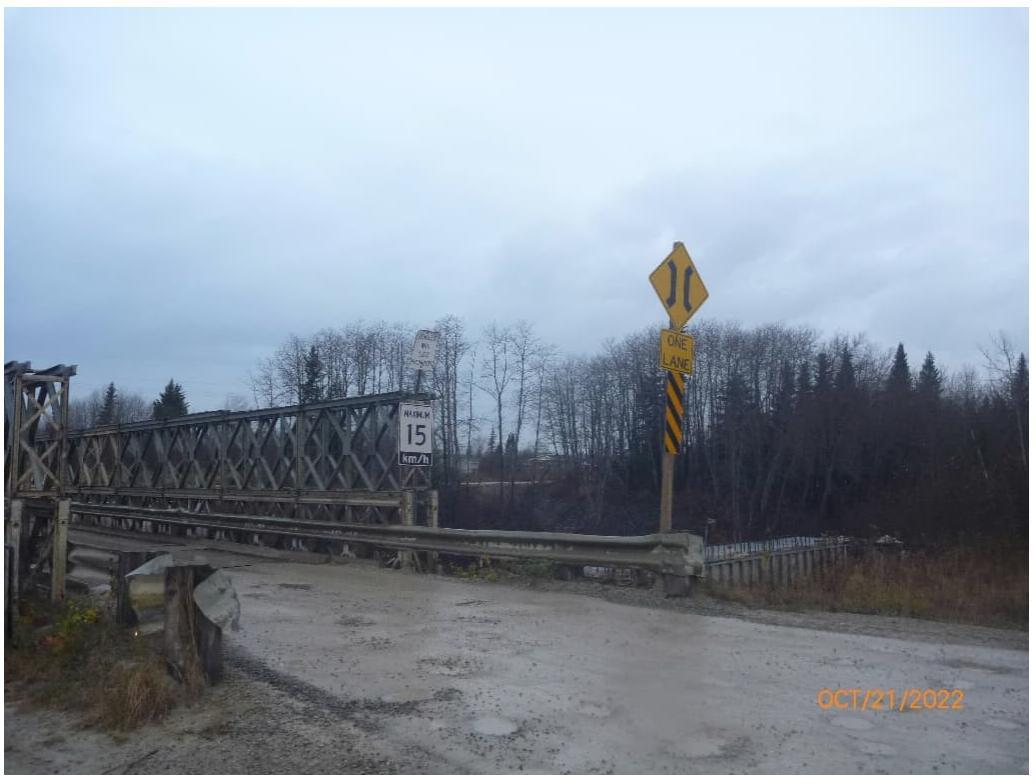
Typical Signs on Approach

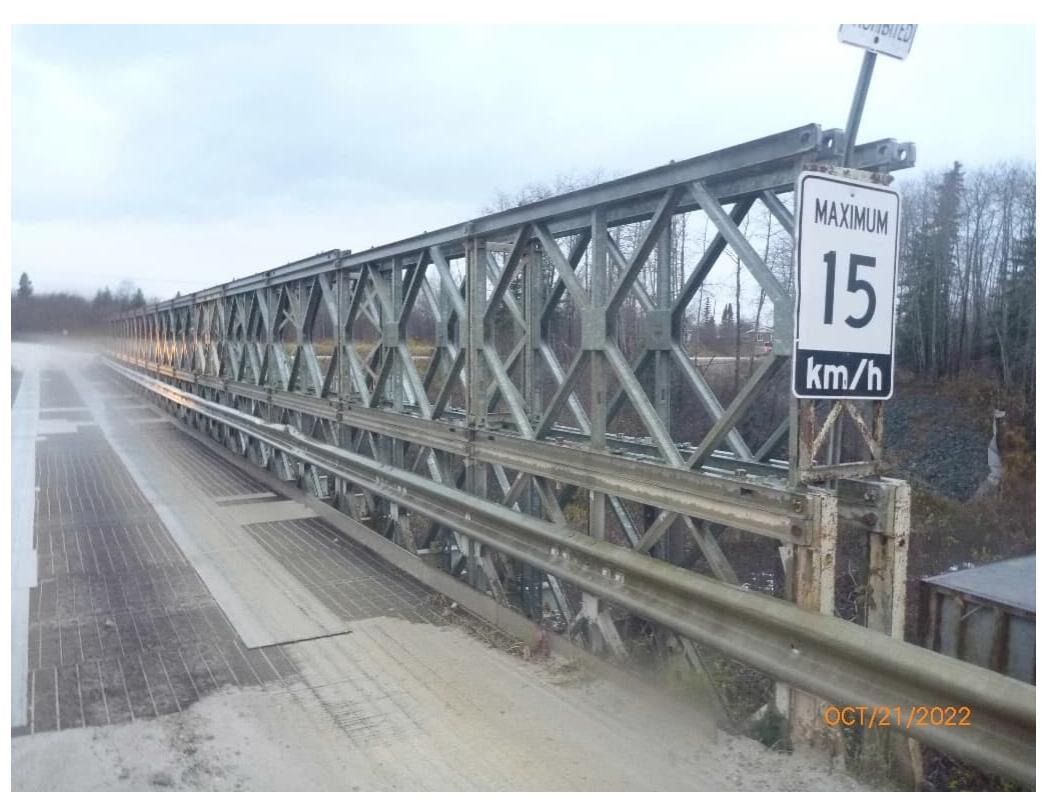
Typical Double Truss Member of Bailey Bridge

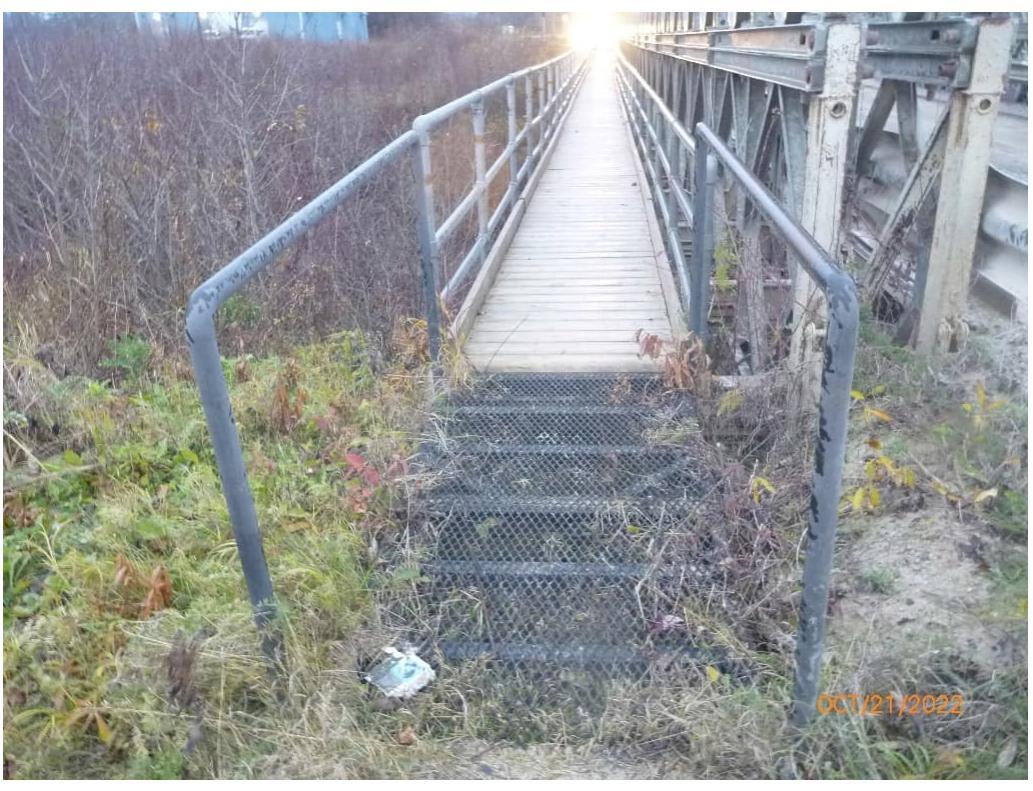
Looking South at Cantilevered Walkway

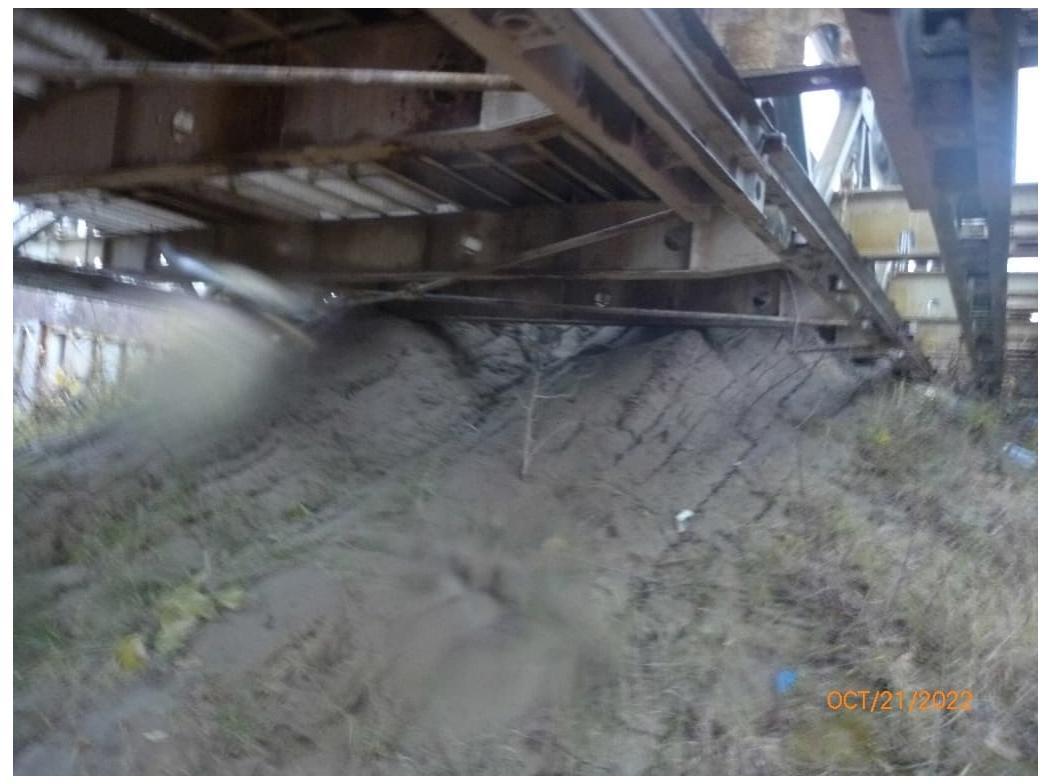
North Abutment

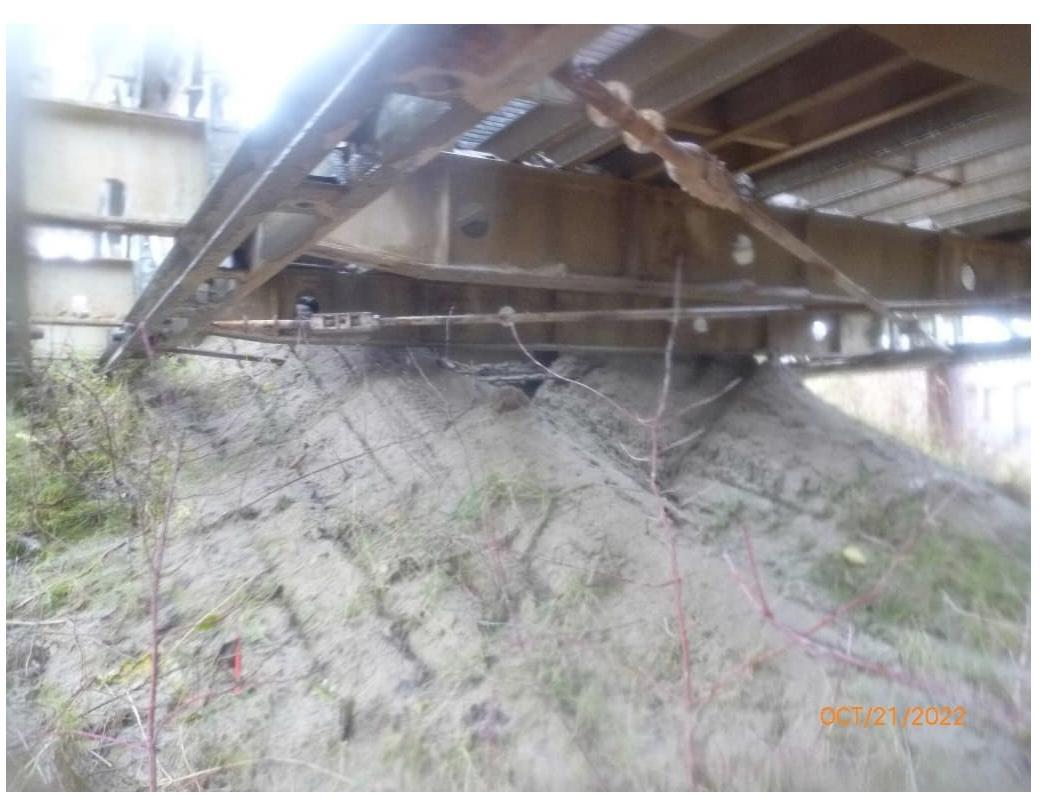
South Abutment

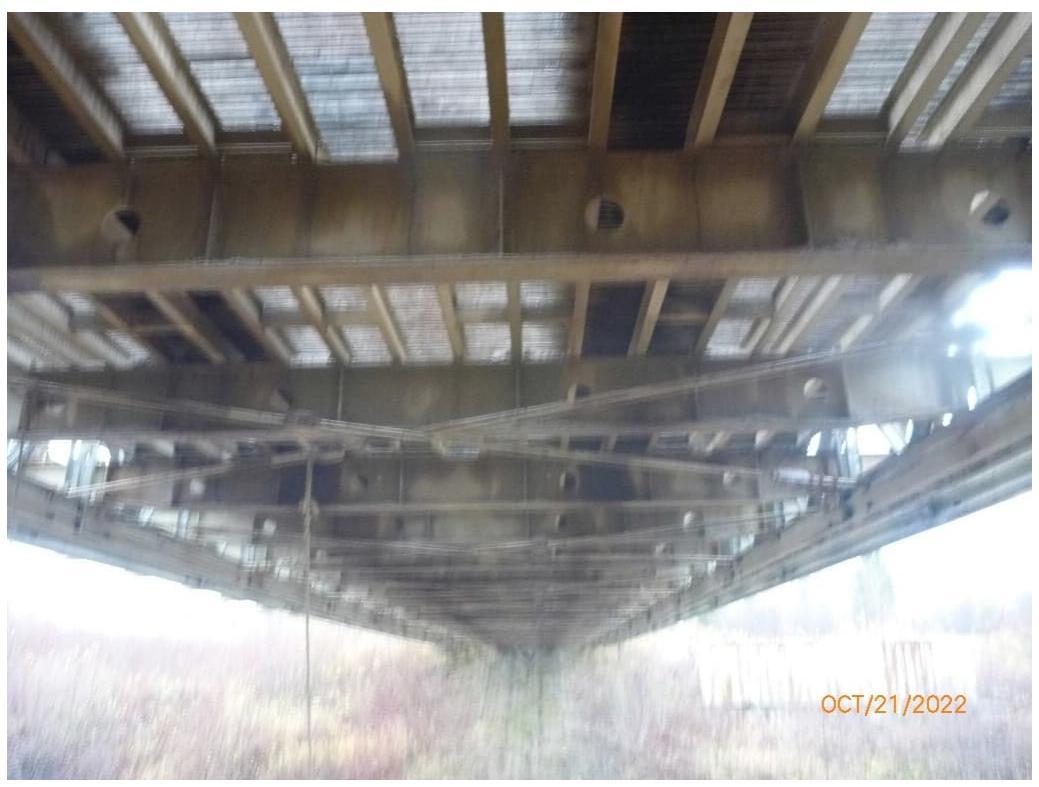
Typical Soffit

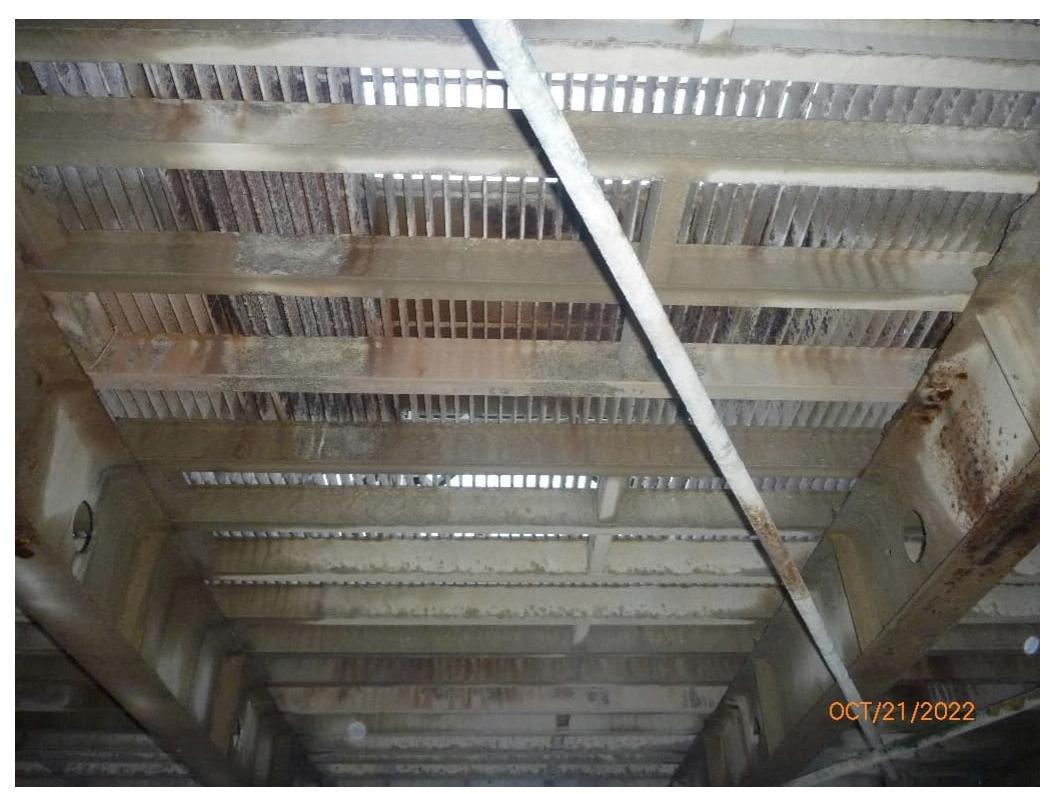
Typical Stringers

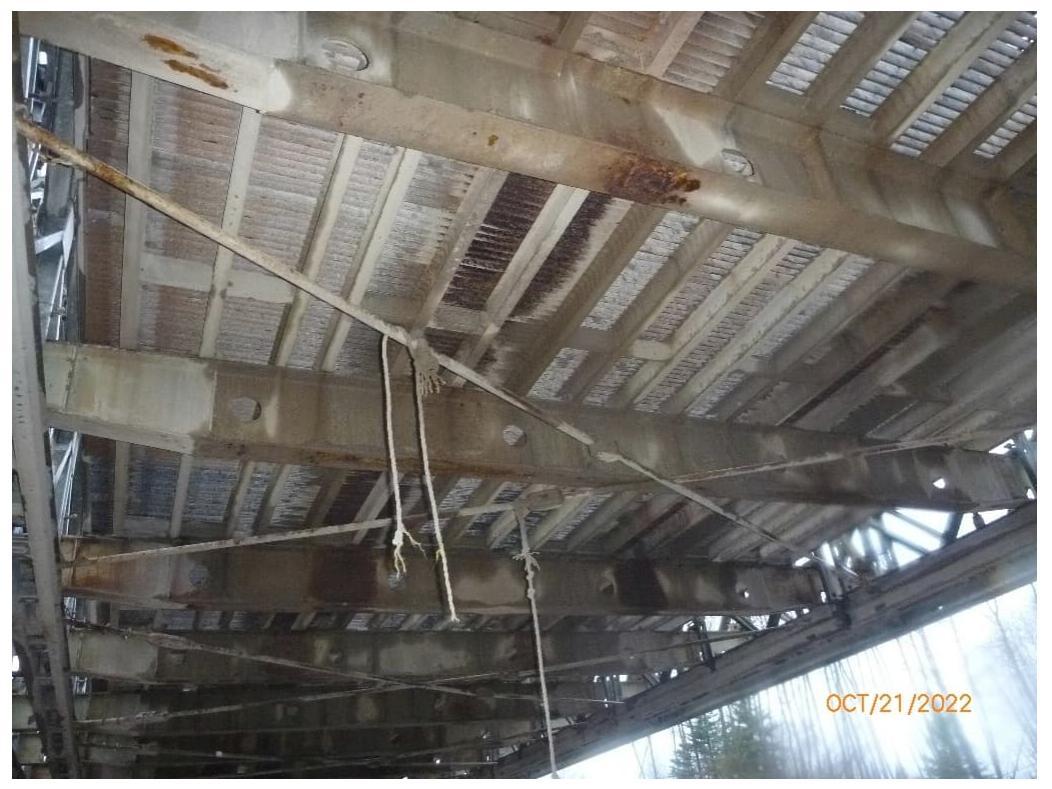
Typical Bracing

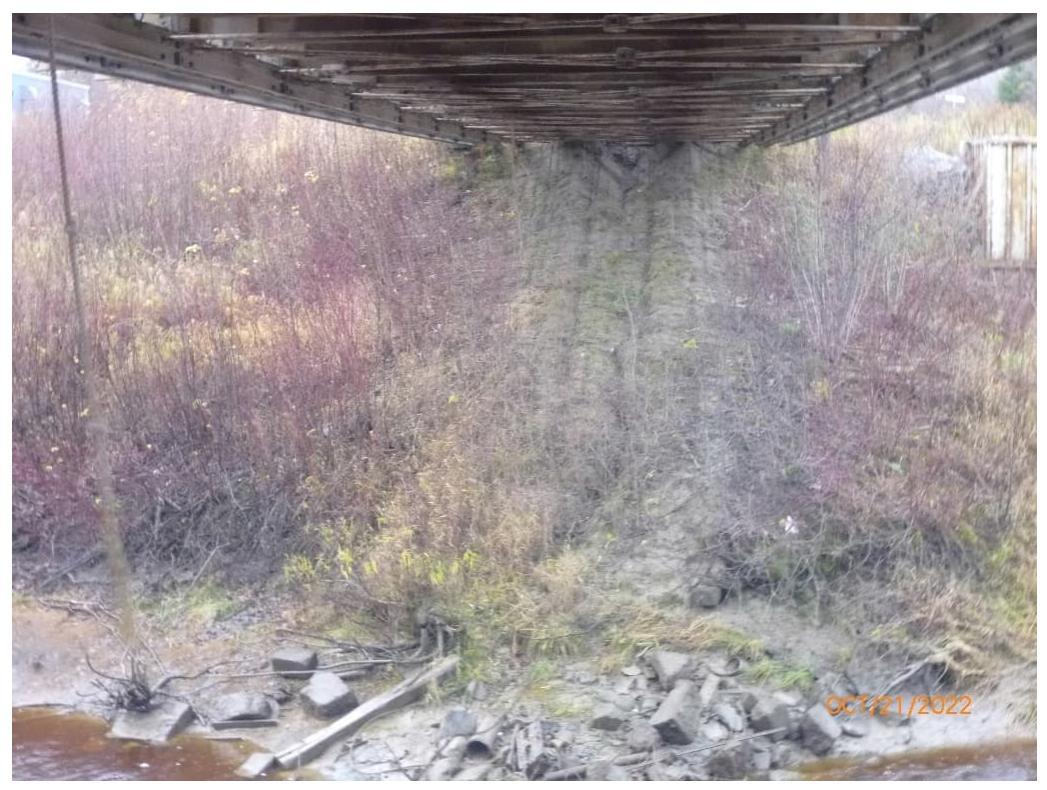
South Embankment

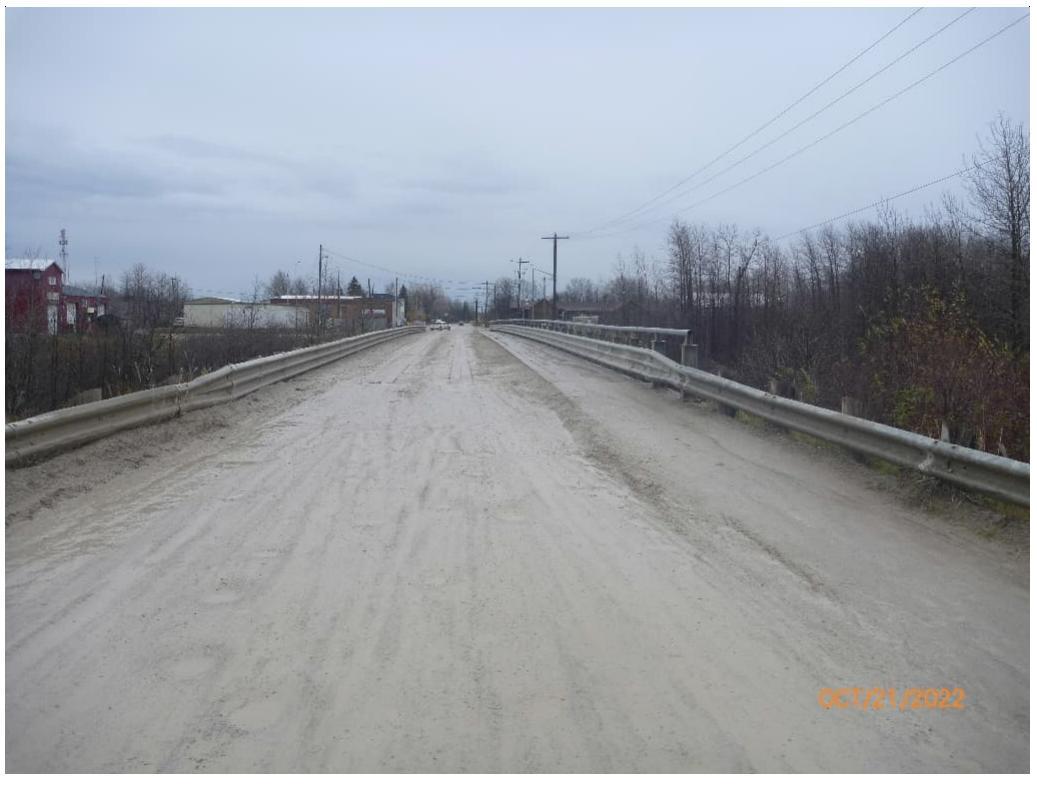
Looking North at Bridge

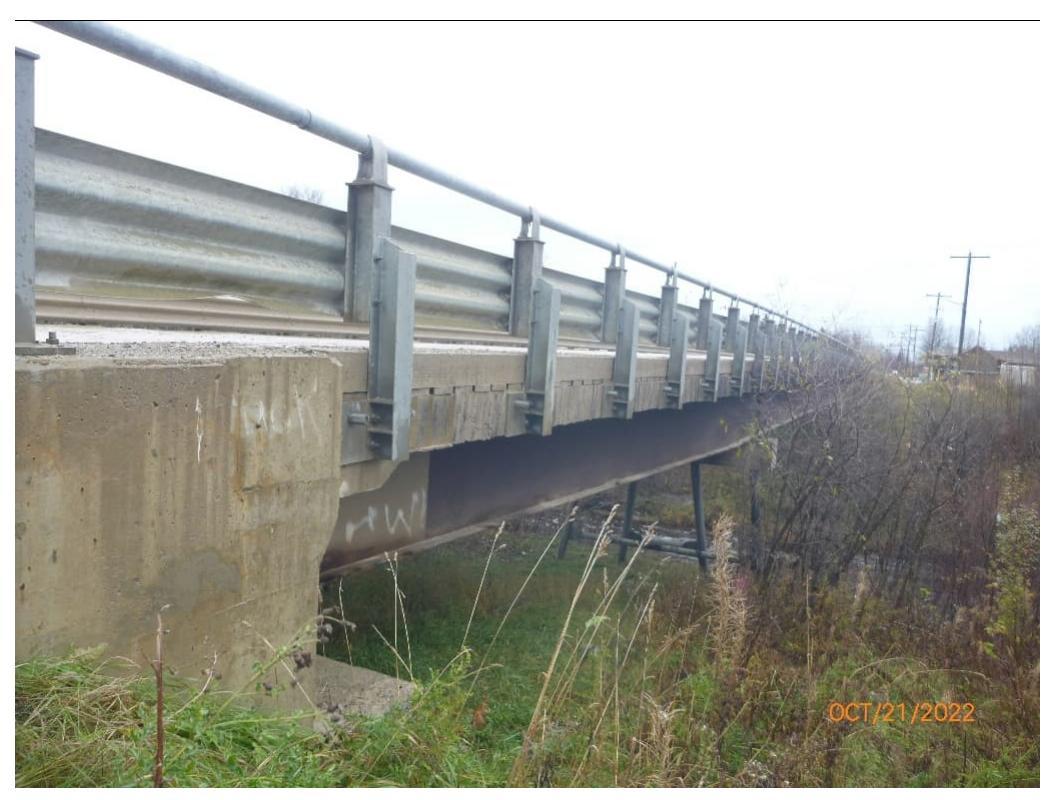
East Elevation

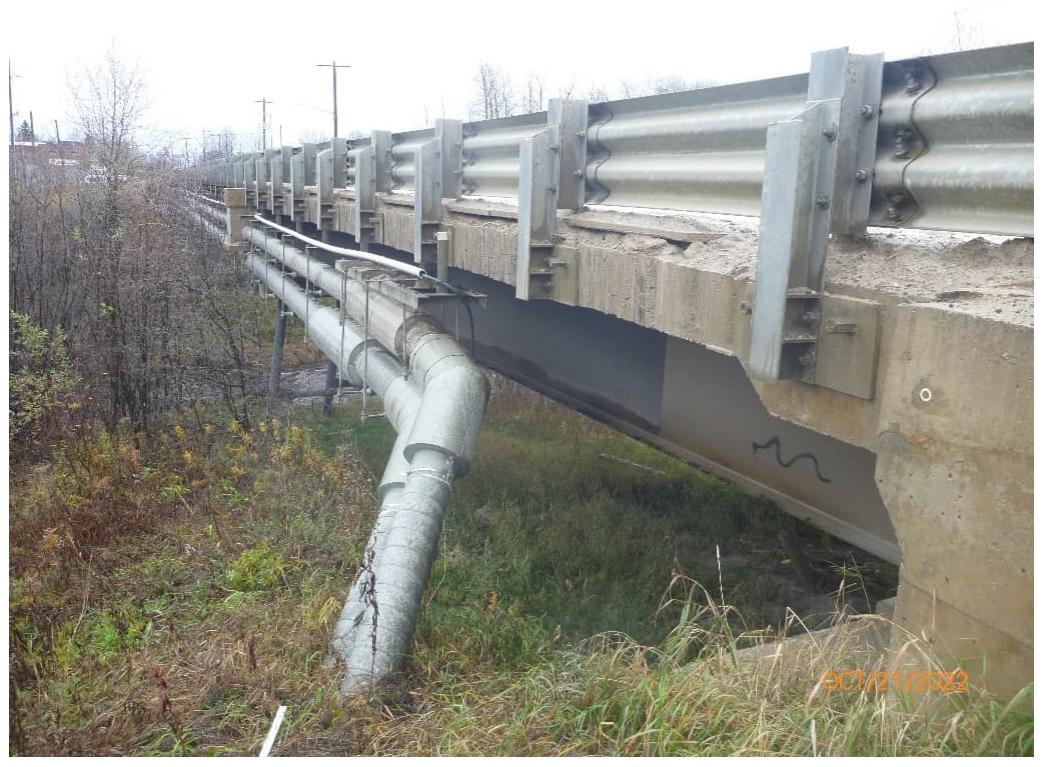
West Elevation

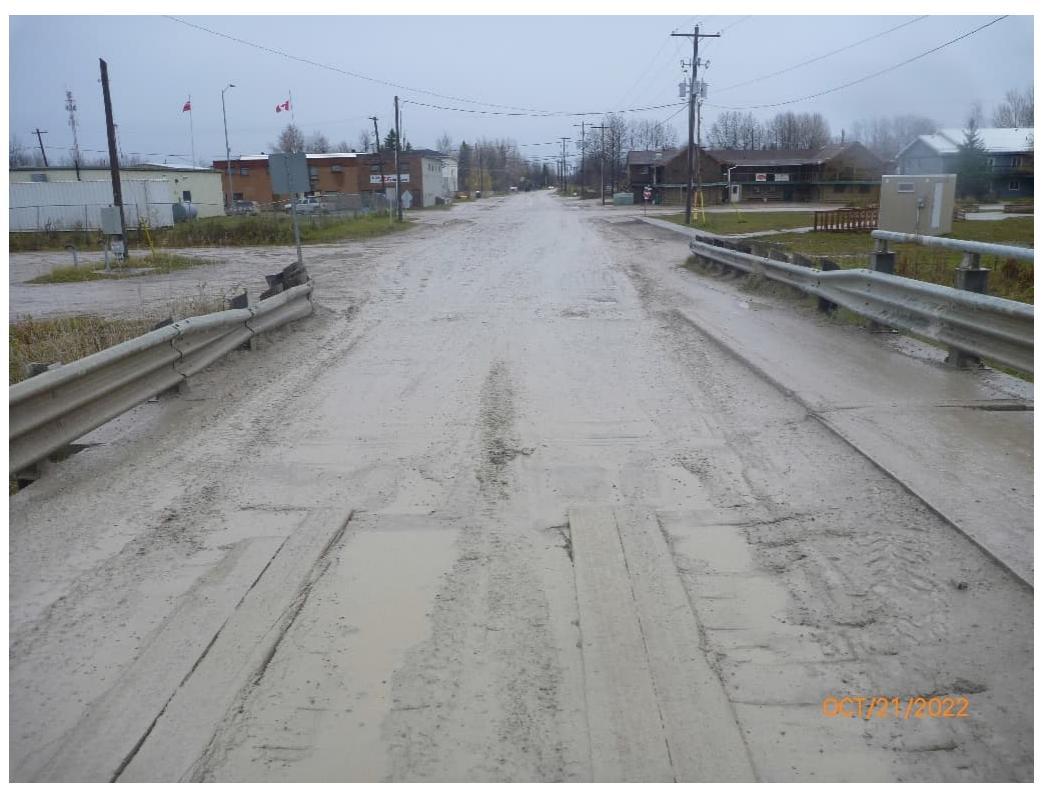
Looking North at North Approach

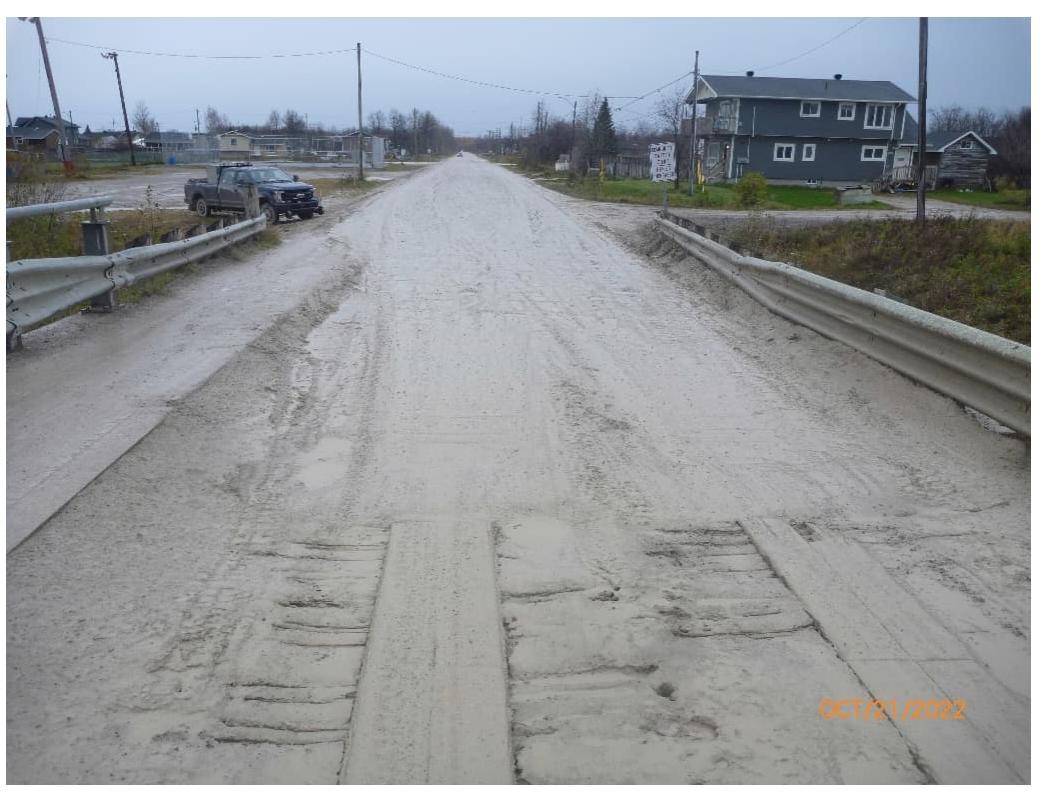
Looking South at South Approach

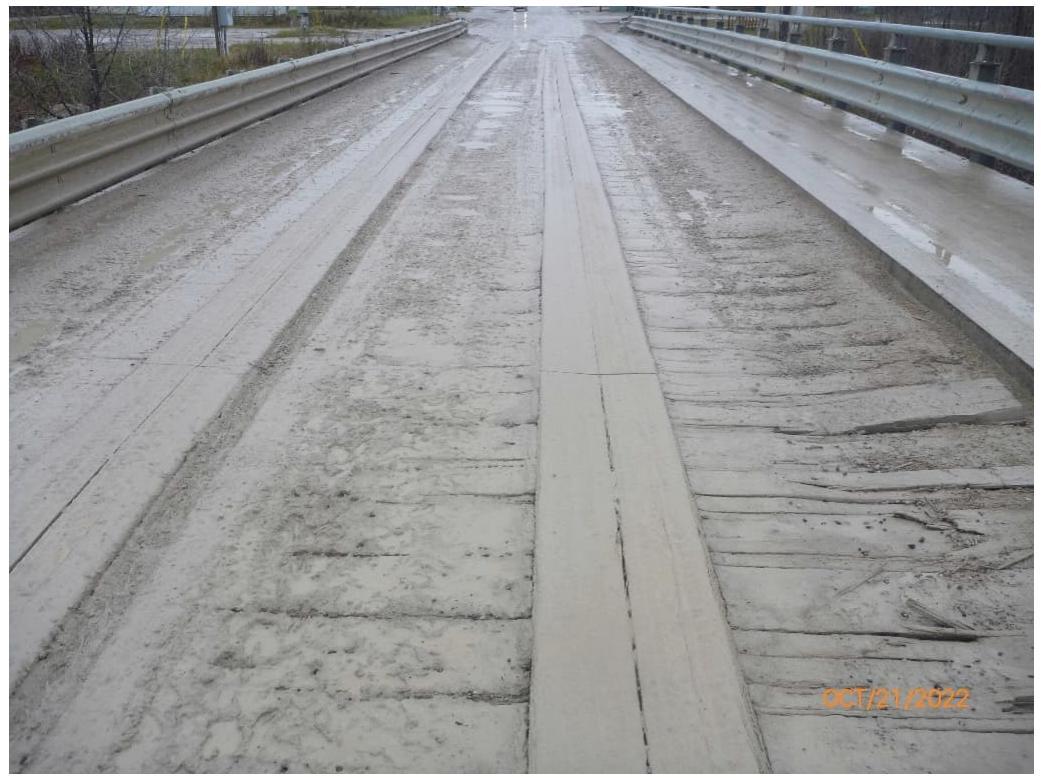
Looking North at Deck from Centre of Bridge

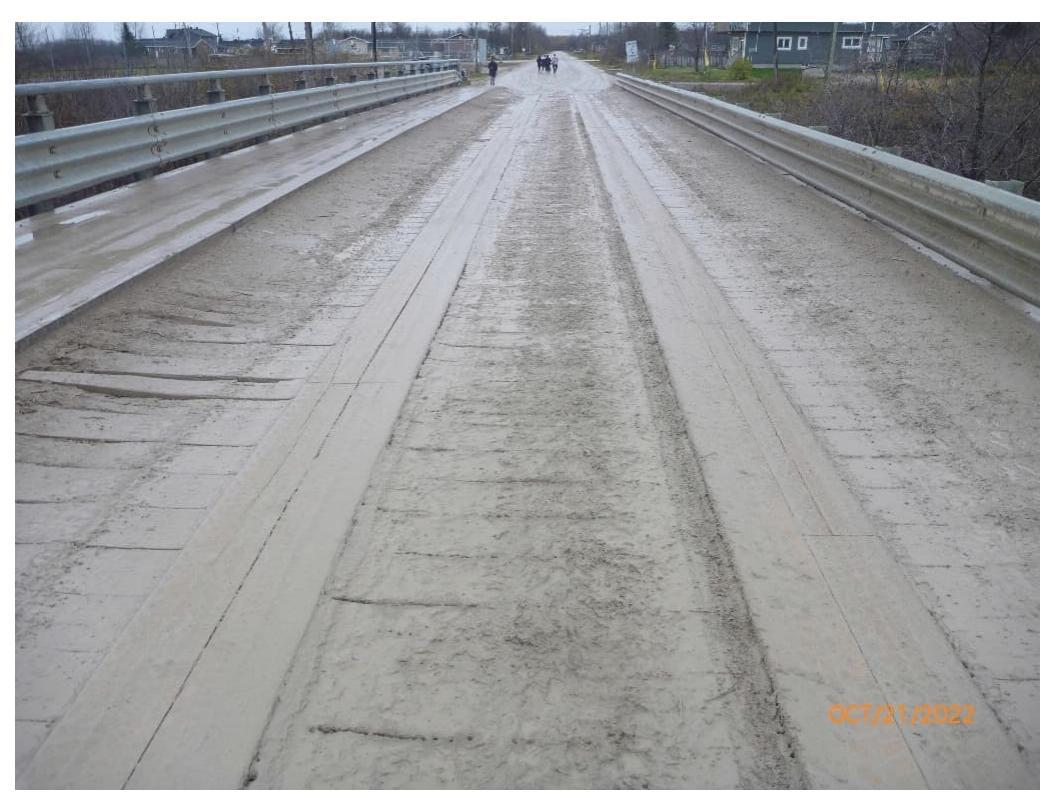
Looking South at Deck from Centre of Bridge

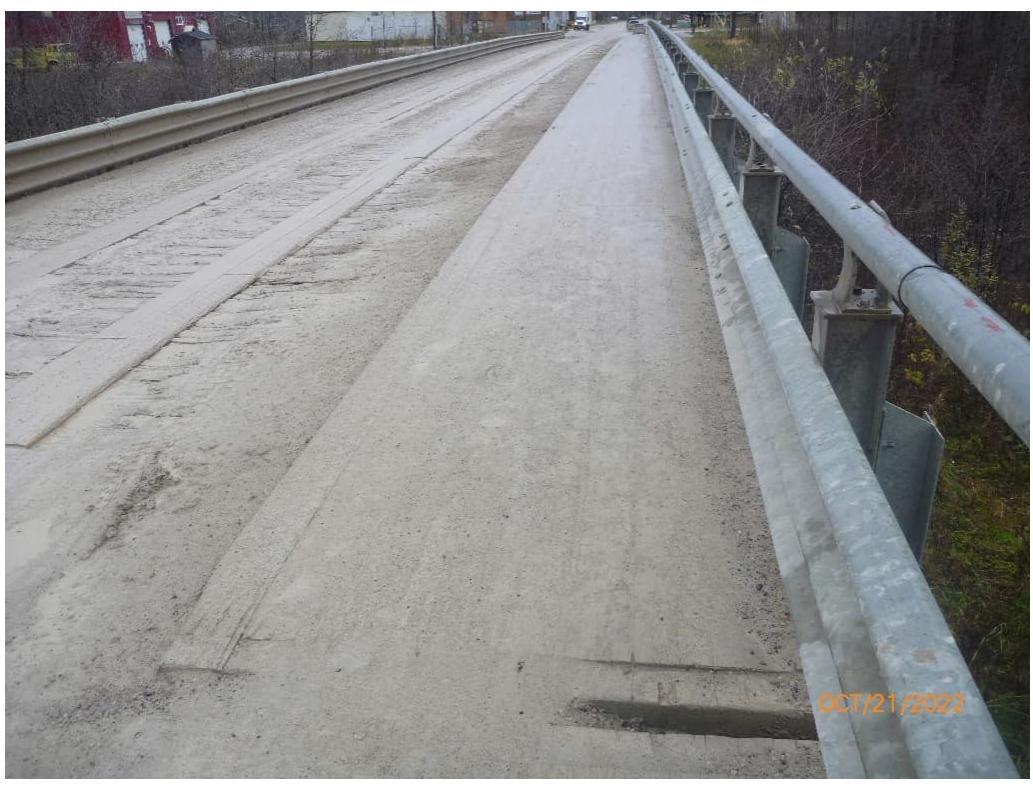
Looking North at East Sidewalk

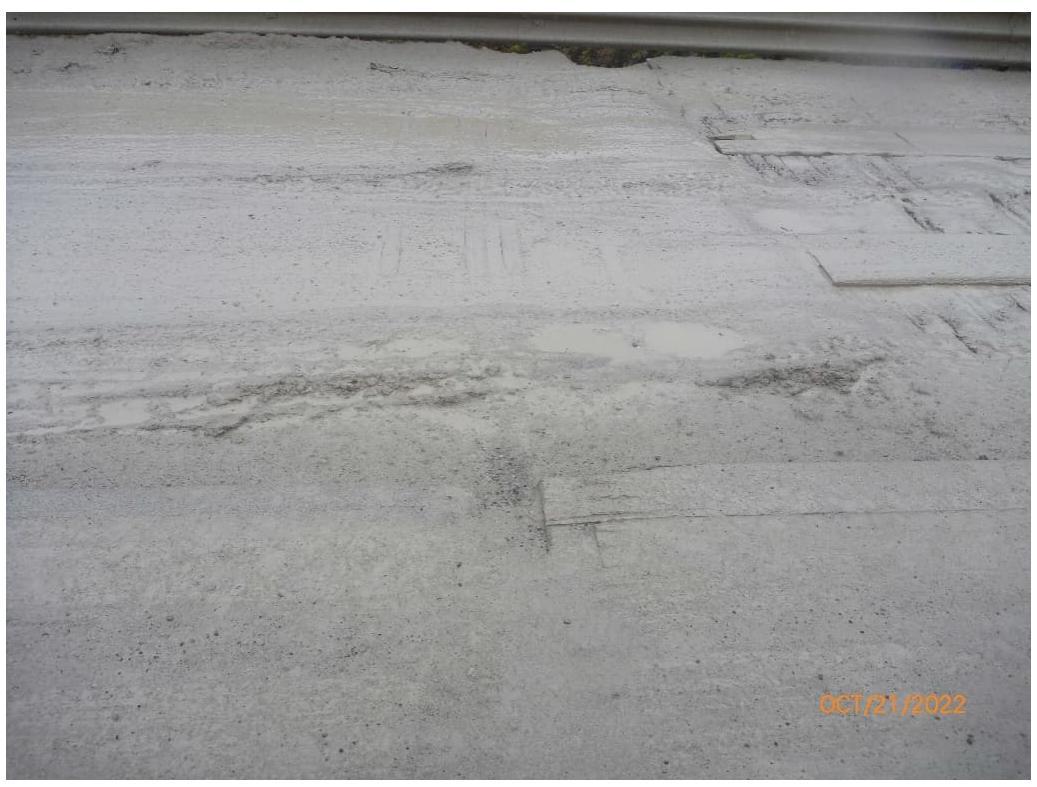
Looking West at South Expansion Joint

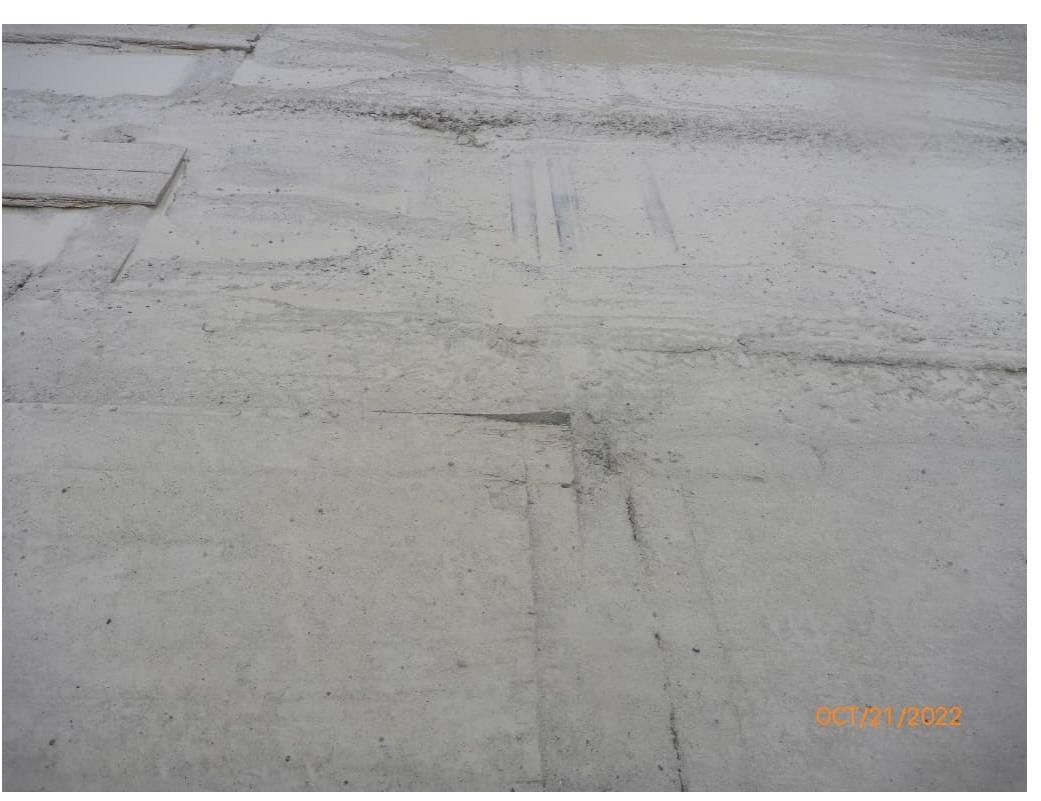
Looking West at North Expansion Joint

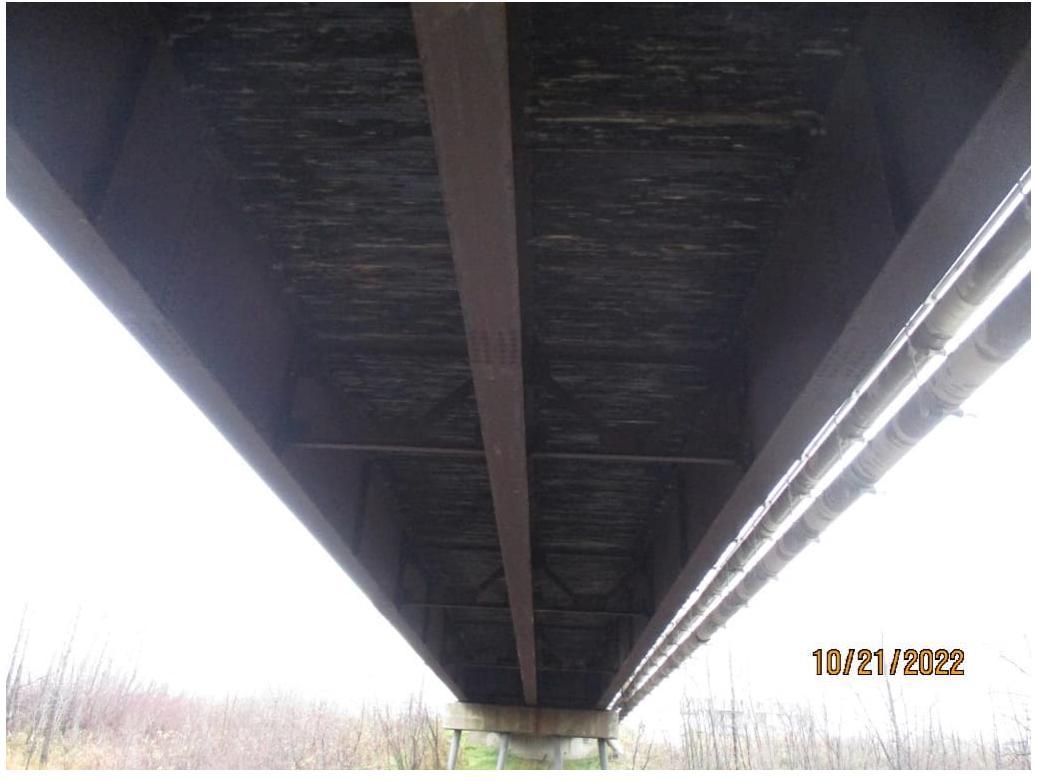
Typical Soffit

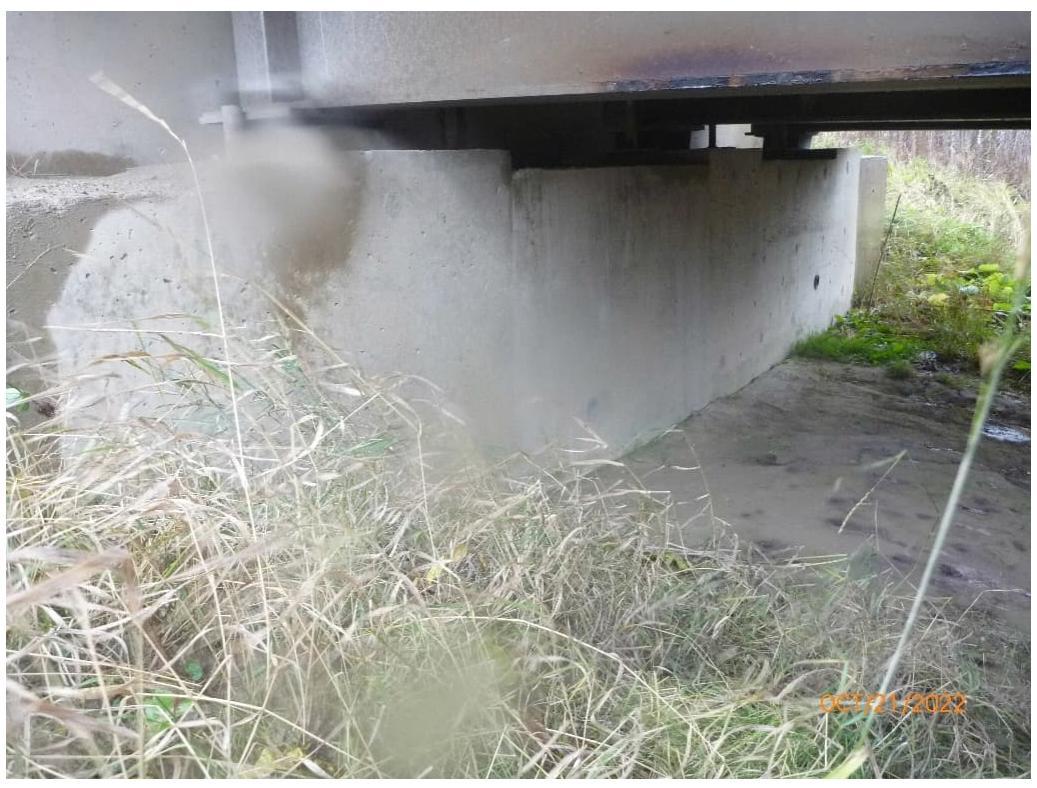
North Abutment

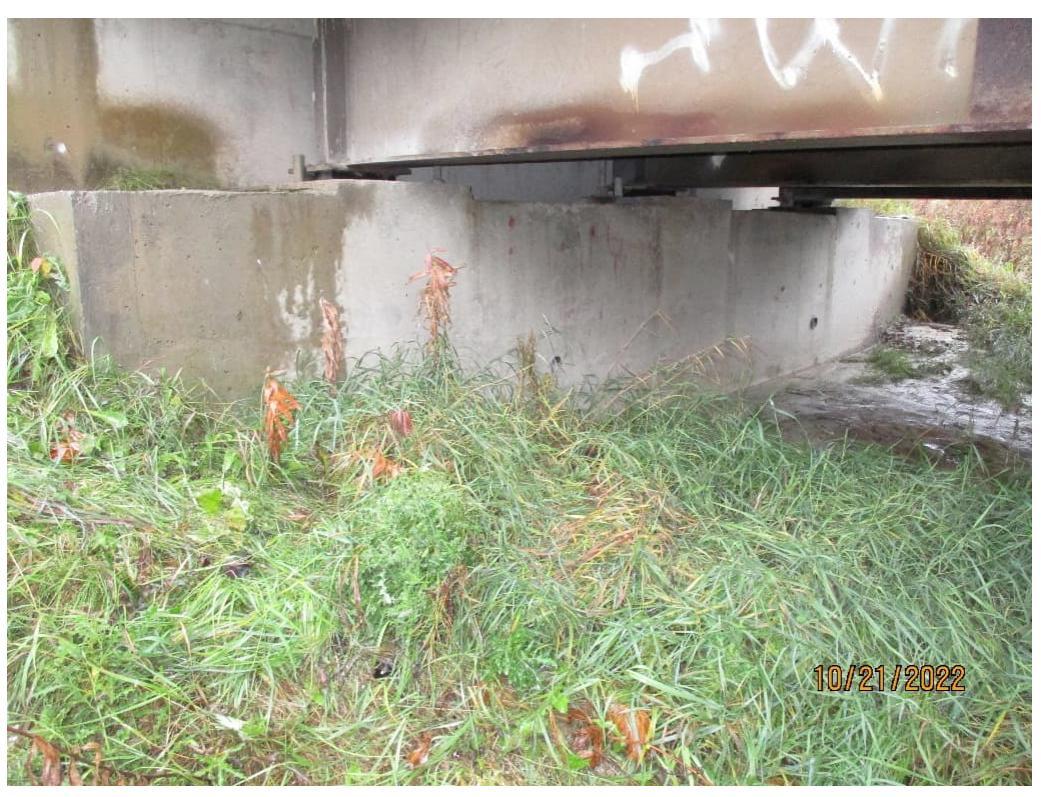
South Abutment
