REQUEST FOR PROPOSALS (RFP)

WATER AND WASTEWATER FACILITIES OPERATION AND MAINTENANCE SERVICES

The Corporation of the Town of Moosonee

AECOM was retained by the Town of Moosonee for Professional Services related to the inspection of Butler Creek, Ferguson Road, Quarry Road and Atim Road Bridges in accordance with the Ontario Structure Inspection Manual. This report summarizes the findings of the 2022 inspections including updated municipal structure inspection forms with recommendations for required bridge maintenance, rehabilitation and/or replacements.

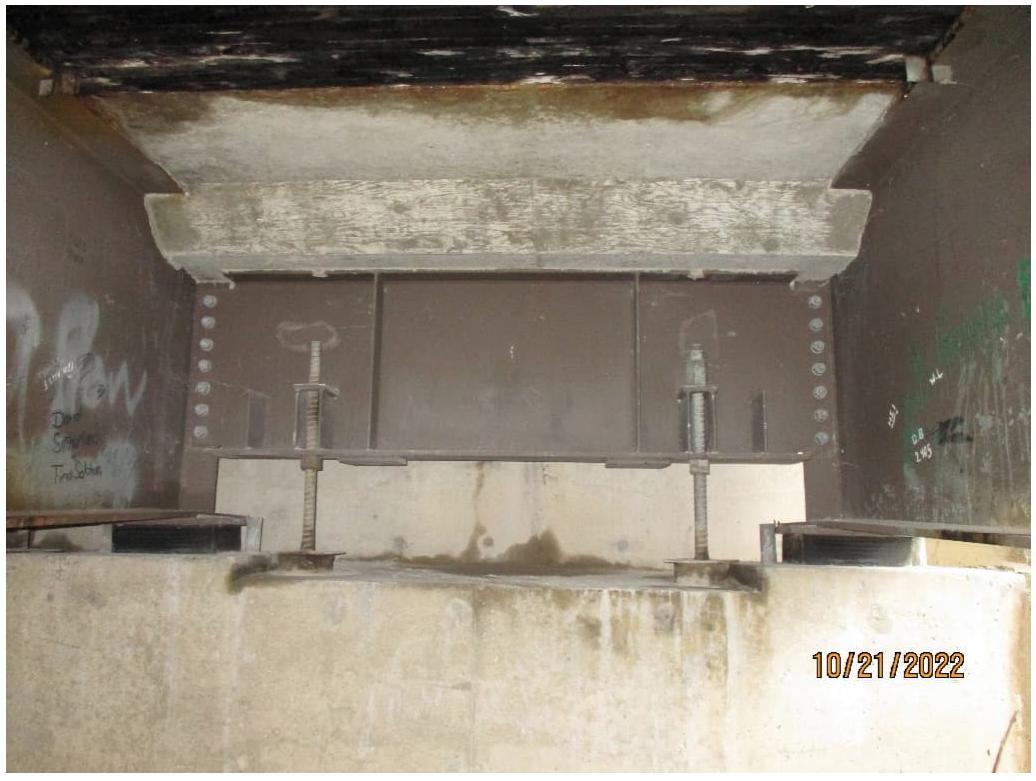
Typical Abutment Diaphragm

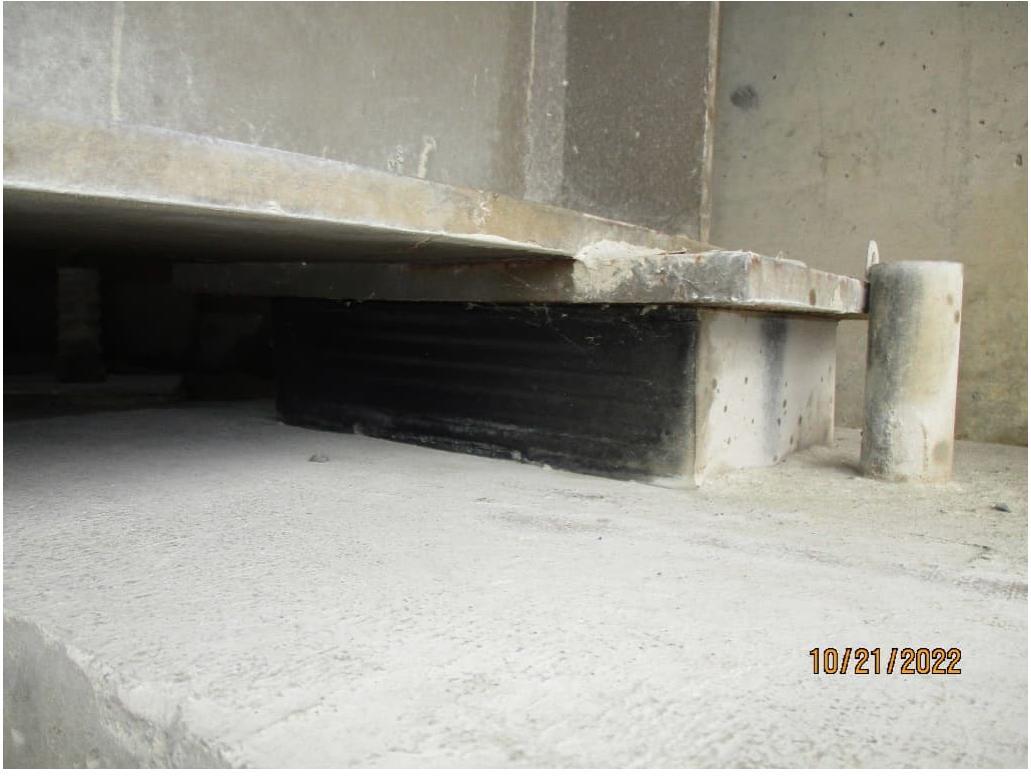
Typical Abutment Bearing

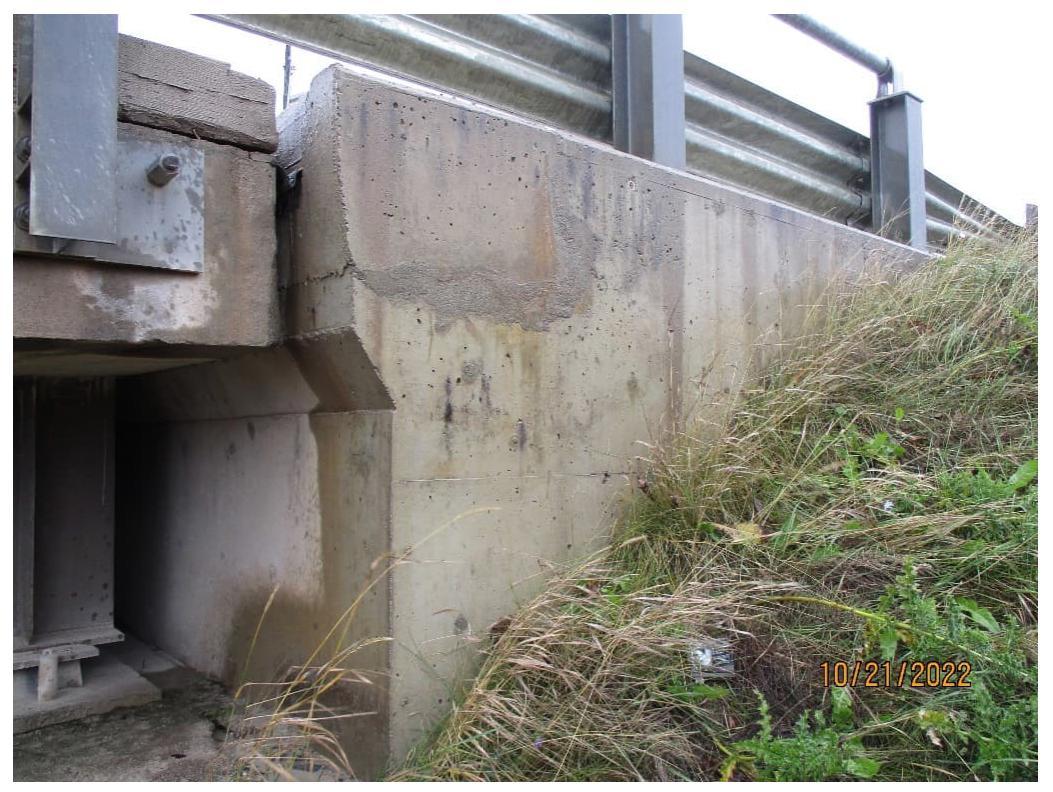
Typical Wingwall

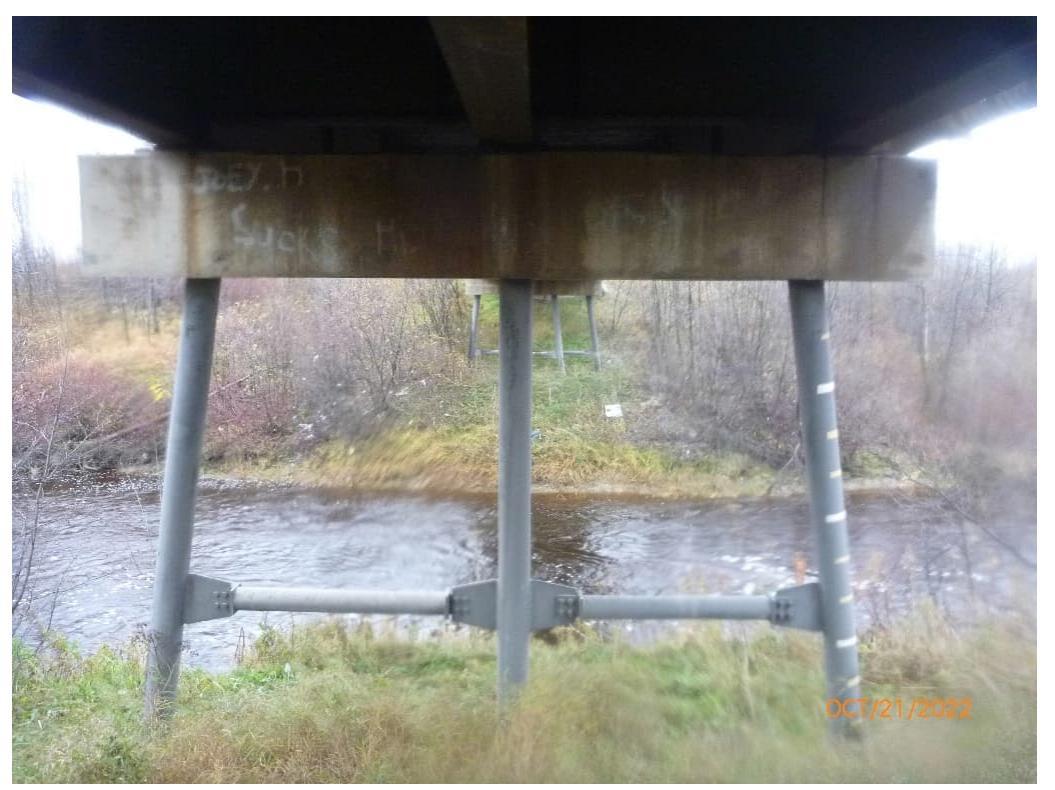
Typical Pier

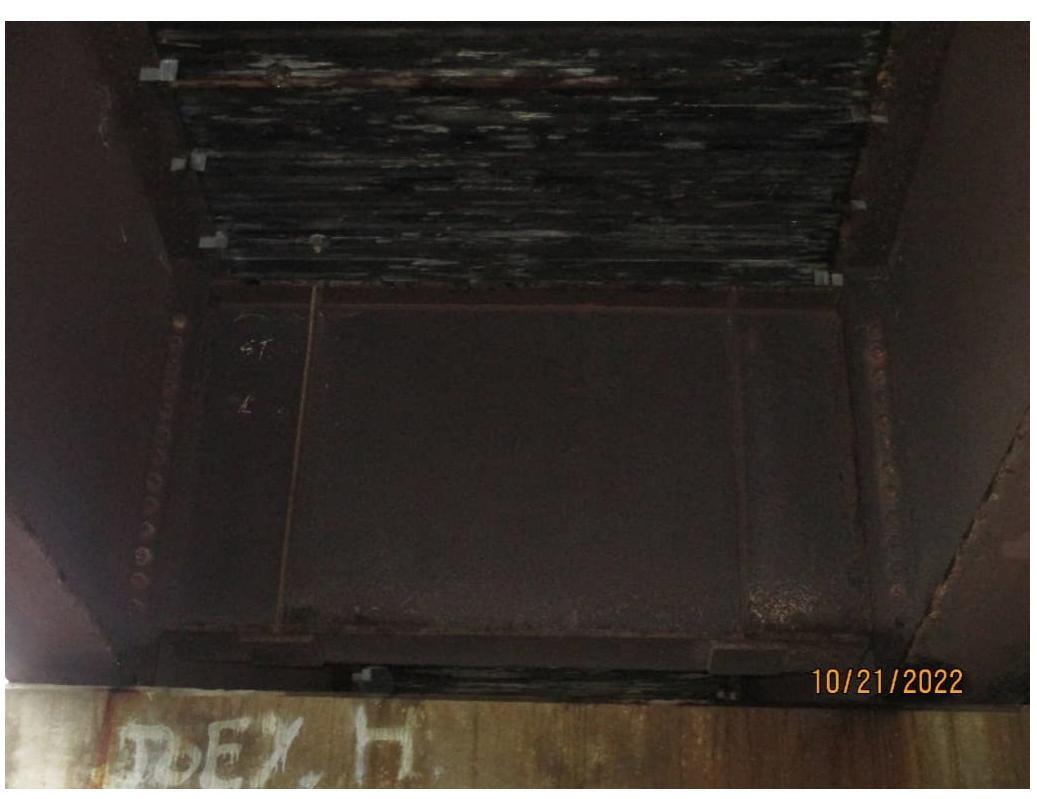
Typical Pier Diaphragm

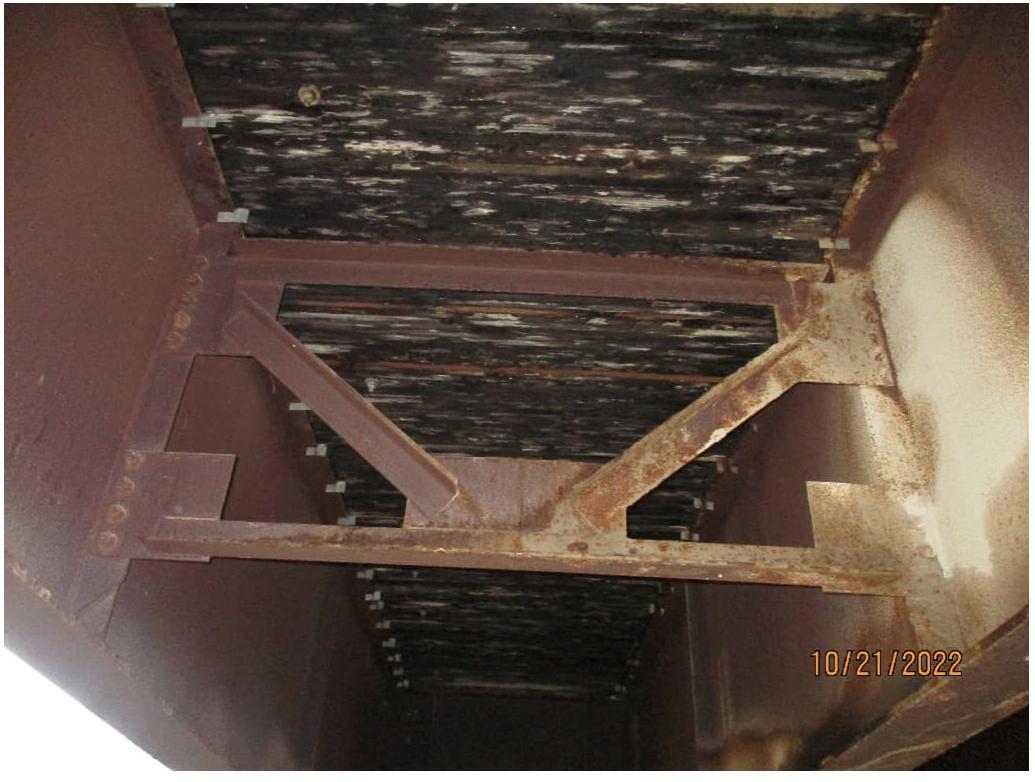
Typical Intermediate Diaphragm

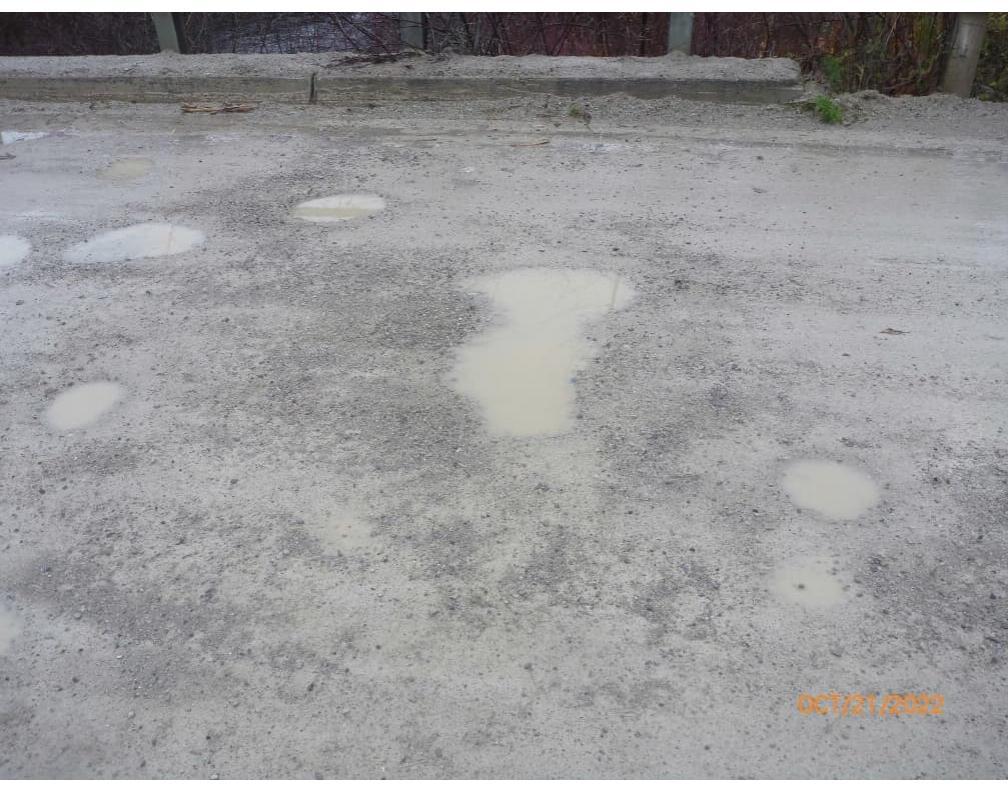
Pothole on Approach

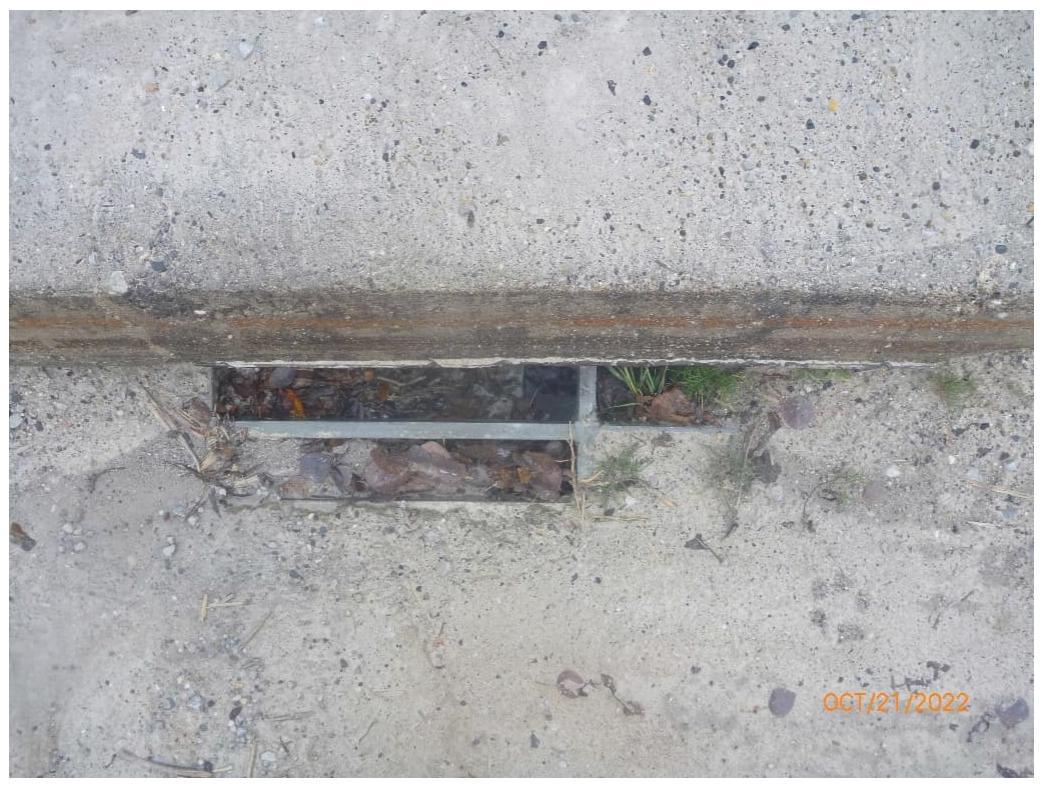
Deck Drain Catch Basin Filled with Debris

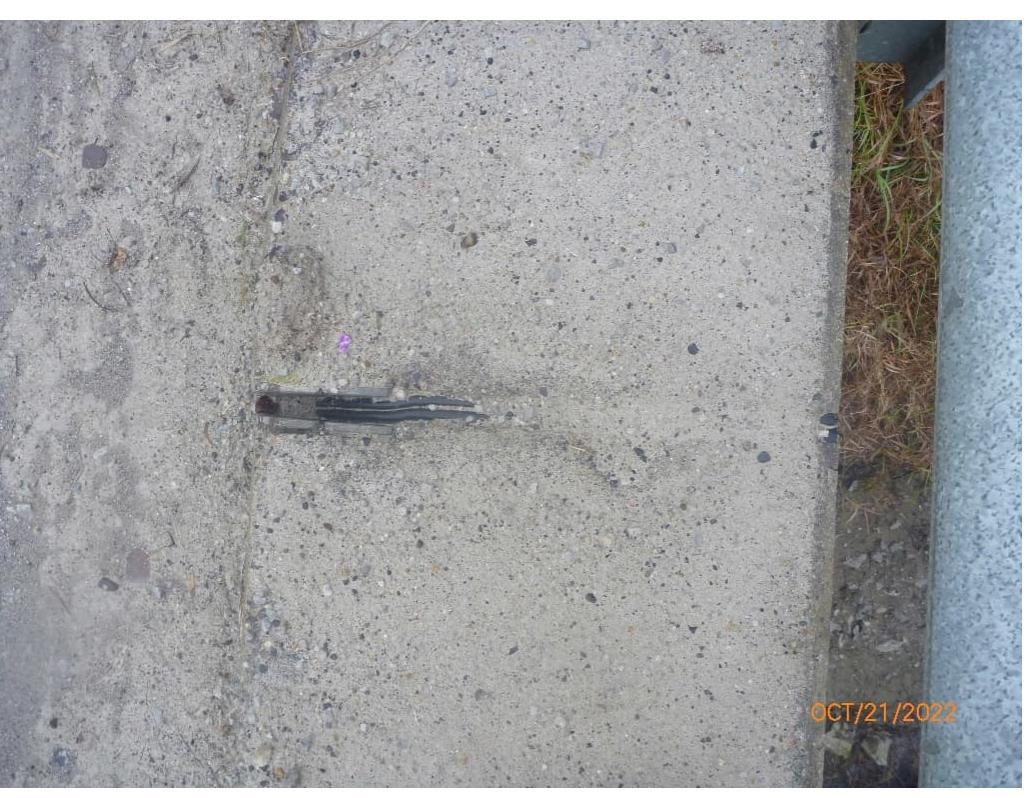
Curb Covered with Sand and Gravel

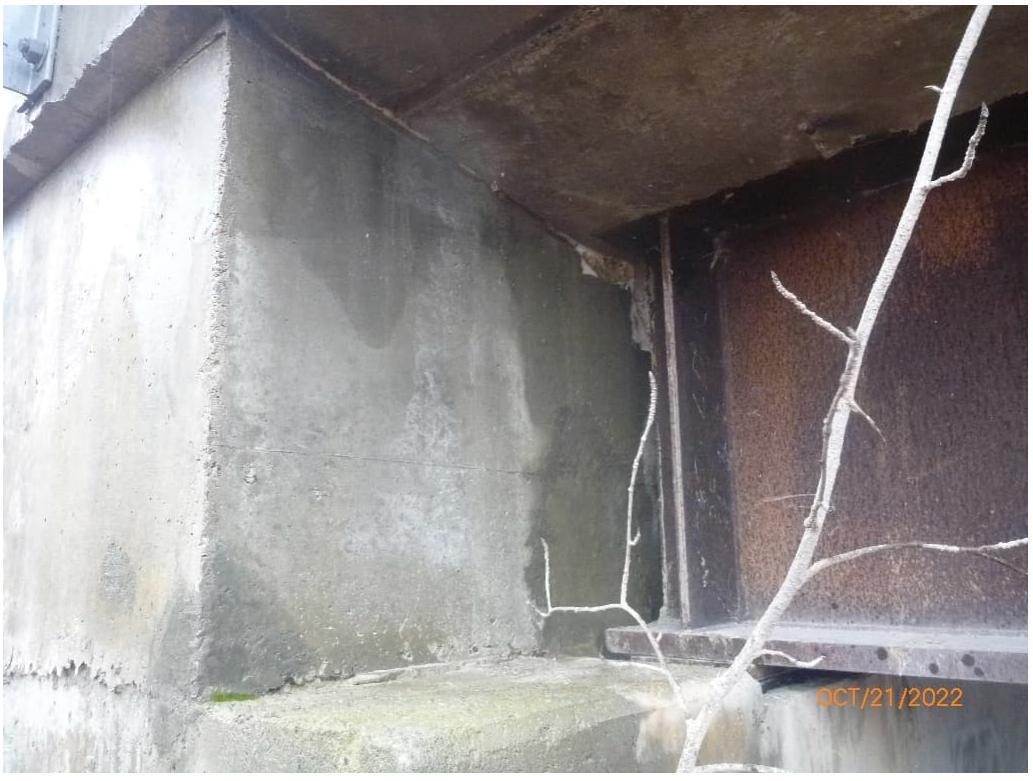
Wet Areas on Ballast Wall

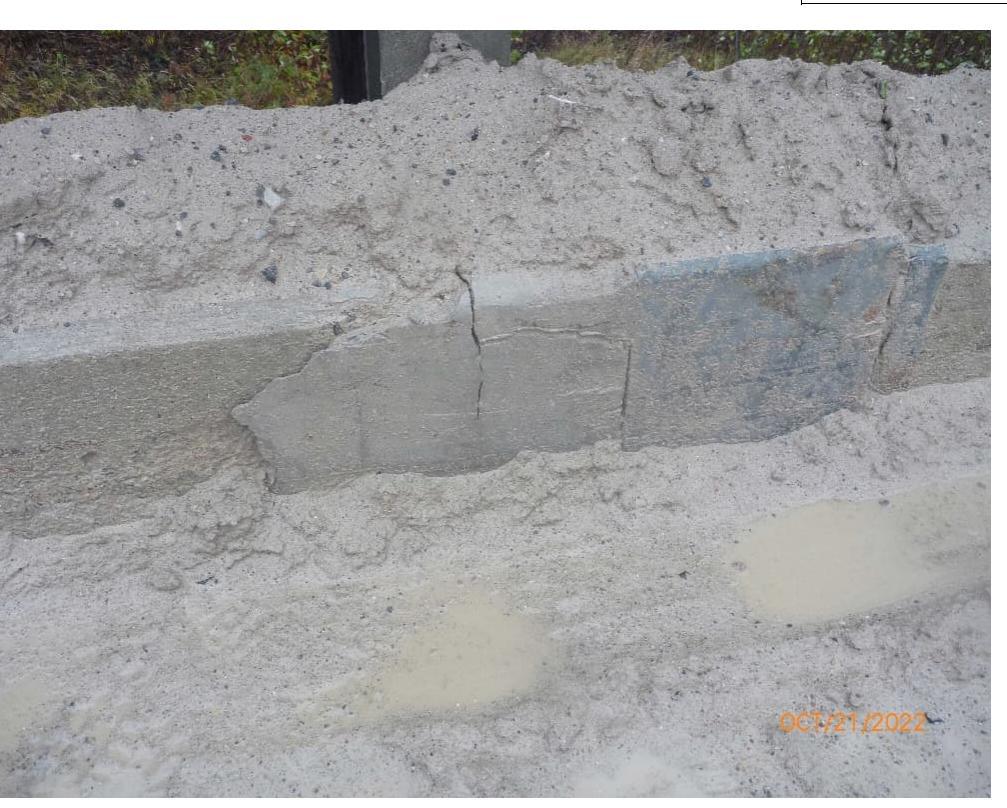
Delamination on Curb

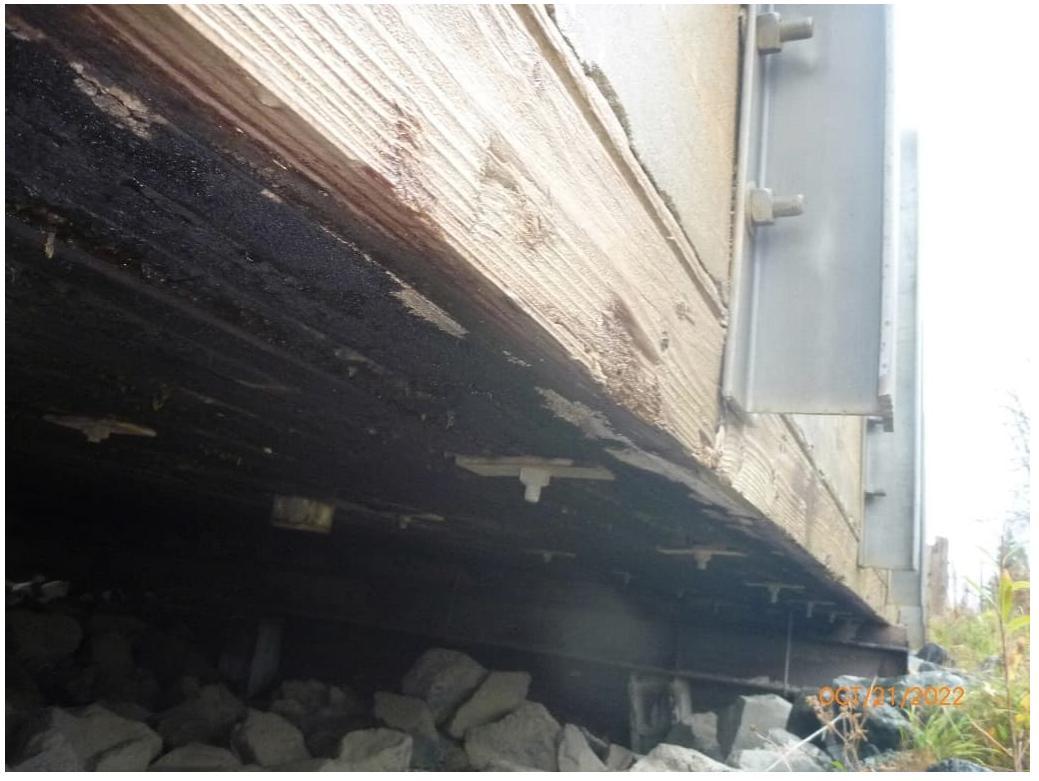
Weathering of Exterior Soffit

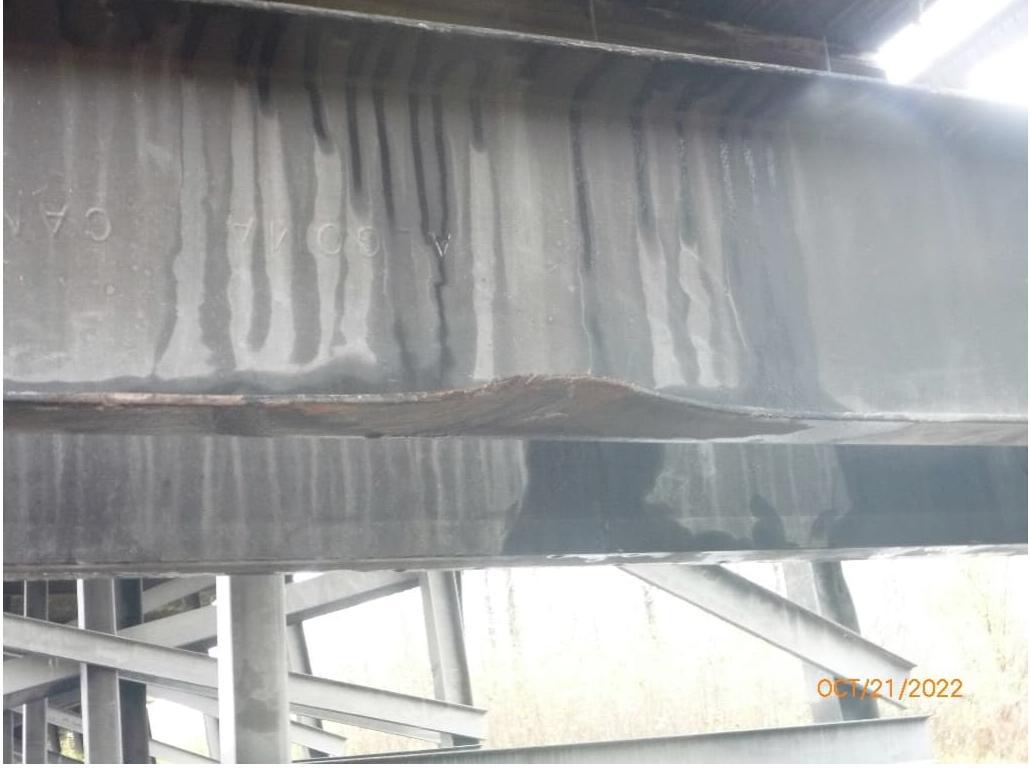
Deformation of Bottom Flange of Pier Cap Beam

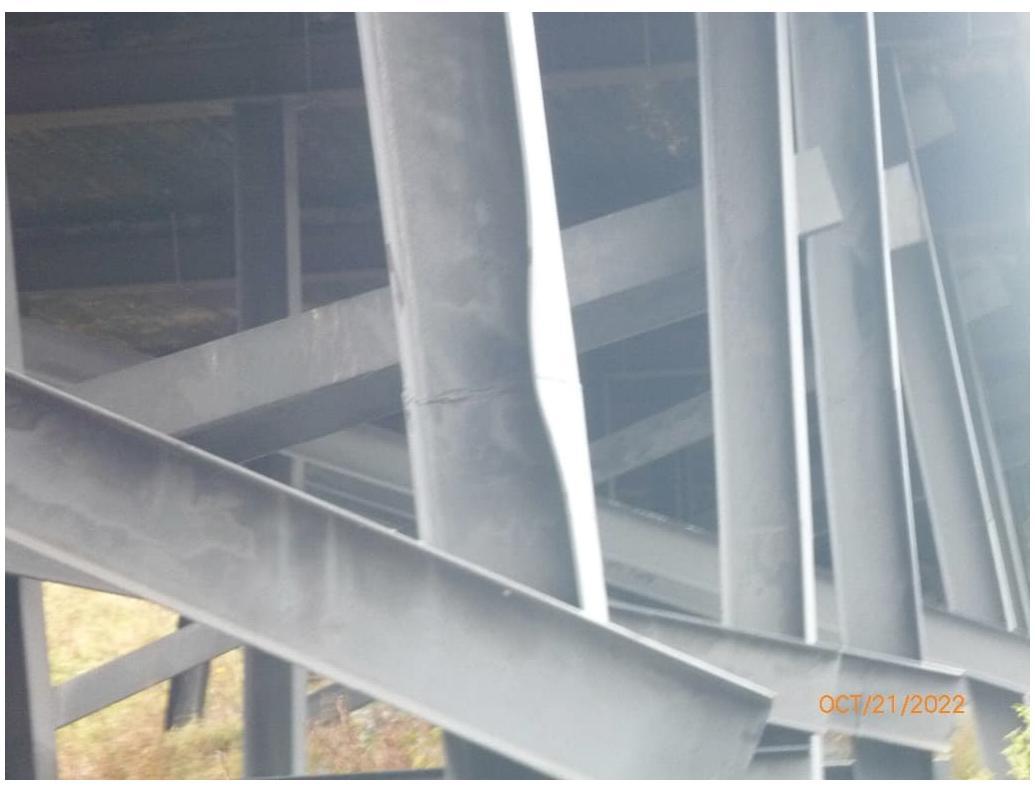
Deformation of H-Pile in Stream
